## **Failure Analysis of Ladle Leakage and Wall Deposit Formation with Low-Nickel Slag Converterin Rotary Kiln–Electric Furnace Nickel Smelting (RKEF)**

Fajar Aditya<sup>1</sup>, Sutarsis<sup>1</sup>, and Meyliana Wulandari<sup>2</sup>

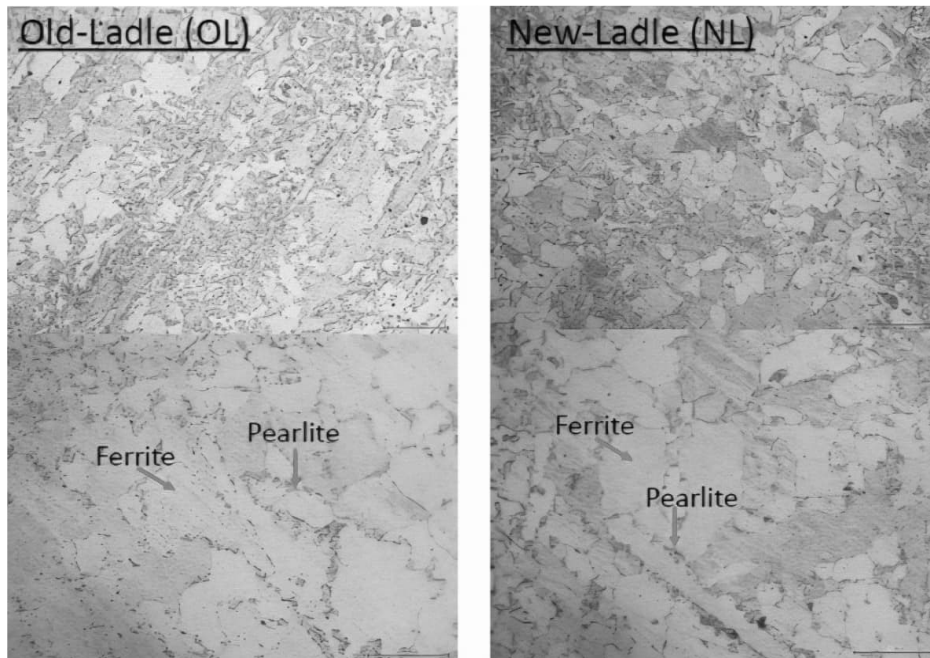
Figure 5 presents the microstructures of both ladles. In both the old and new ladles, ferrite (light regions) and pearlite (dark regions) are observed. Quantitative analysis shows that the old ladle contains a lower ferrite fraction of approximately 60%, whereas the new ladle exhibits a higher ferrite content of about 75%, with the remaining fraction consisting of pearlite. Ferrite is a soft and ductile phase, while pearlite is comparatively

Figure 5. Microstructure of old and new ladle

harder (Steel et al., 2024). These observations are consistent with the chemical composition results in Table 5, as higher carbon content in steel reduces the ferrite fraction and promotes the formation of harder phases such as pearlite. Based on the data presented, both the old and new ladles comply with the company recommendations, which are based on the ASTM A27 Grade 60–30 standard. However, a difference in carbon content is observed between the two ladles, with the old ladle containing 0.28% carbon and the new ladle containing 0.18% carbon. This variation in carbon content is corroborated by microstructural analysis, where the old ladle comprises approximately 60% ferrite and 40% pearlite, while the new ladle consists of about 75% ferrite and 25% pearlite. Additionally, both ladles exhibit comparable mechanical properties, as summarized in Table 6.

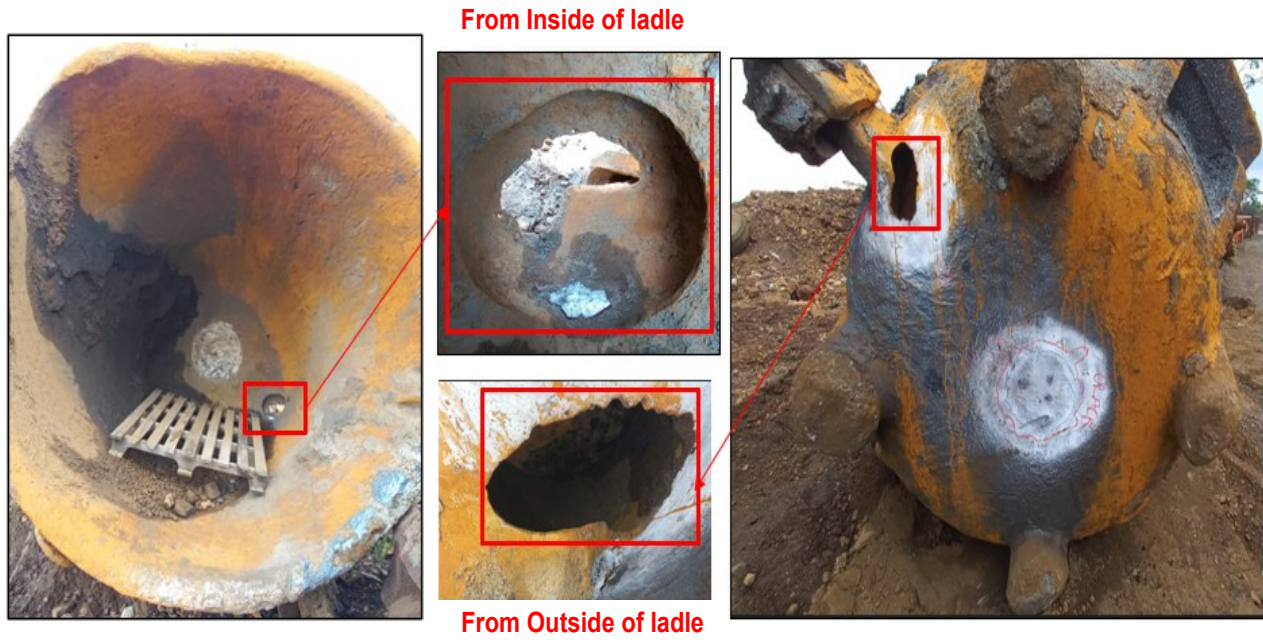
Immediately after the ladle leak incident, an investigation was conducted to document and analyze the ladle leak point (Figure 6).

The thin deposit of low-nickel converter slag allowed penetration by the high-nickel converter slag during pouring due to its higher temperature (approximately 1220 °C for high-nickel slag compared to 1200 °C for low-nickel slag). In the failure area, a pit was also observed that formed from the internal surface (Figure 11), indicating that the ladle failure originated from inside.

Figure 6. Visual observation of ladle leaking from inside and outside

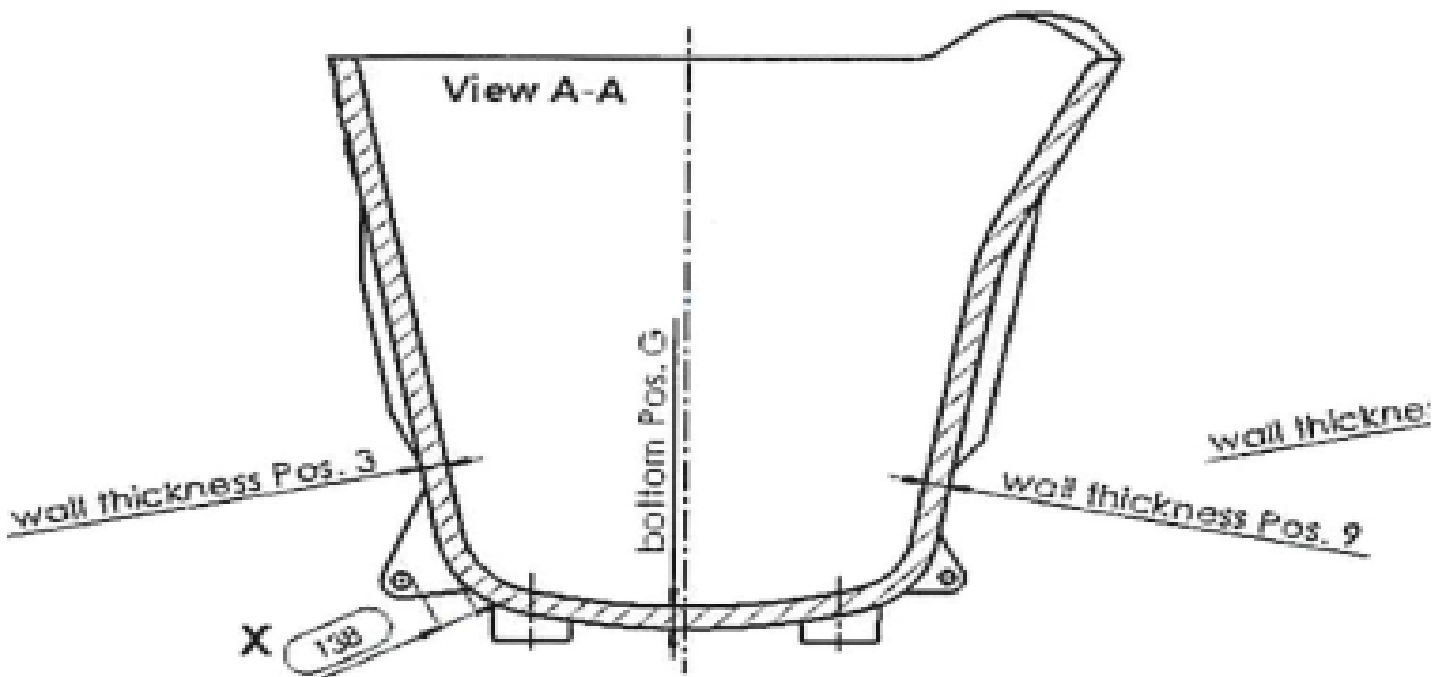
Figure 7 indicates that the ladle thickness in the leaking area has been reduced to 39 mm from its original thickness of 90 mm. This region is particularly susceptible to high mechanical loads from slag and matte during the pouring process from the converter, as illustrated in Figure 8. In addition to the mechanical load concentrated in the ladle hook area during the initial slag pouring from the converter, it was observed that the low-nickel converter slag deposit within the ladle was relatively thin.

Leakage Position	NDT Thickness of ladle body (mm)			Remark
	Original Design	Pos. 3	Pos. 9	
3	90	39	NA	High Nickel Converter

Figure 7. Leakage point in ladle and its thickness

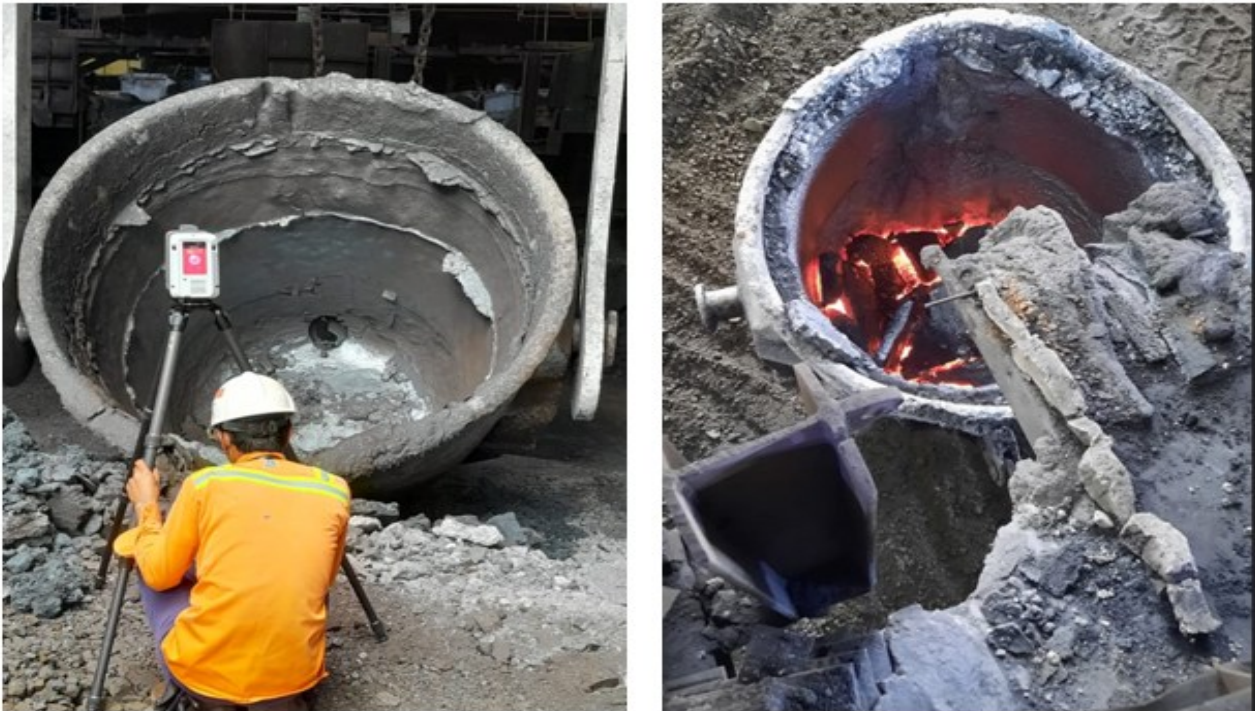
Visually, the deposits in the leaking ladle (Figure 9, left) differ significantly in thickness compared to those in normal ladles (Figure 9, right). This difference is further reflected in the ladle temperature at the time of the incident, which reached 565 °C, considerably higher than the average operating temperature of 335 °C (Figure 10).

Figure 9. Converter slag deposit on the wall of a leaking ladle (left) with another ladle (right)

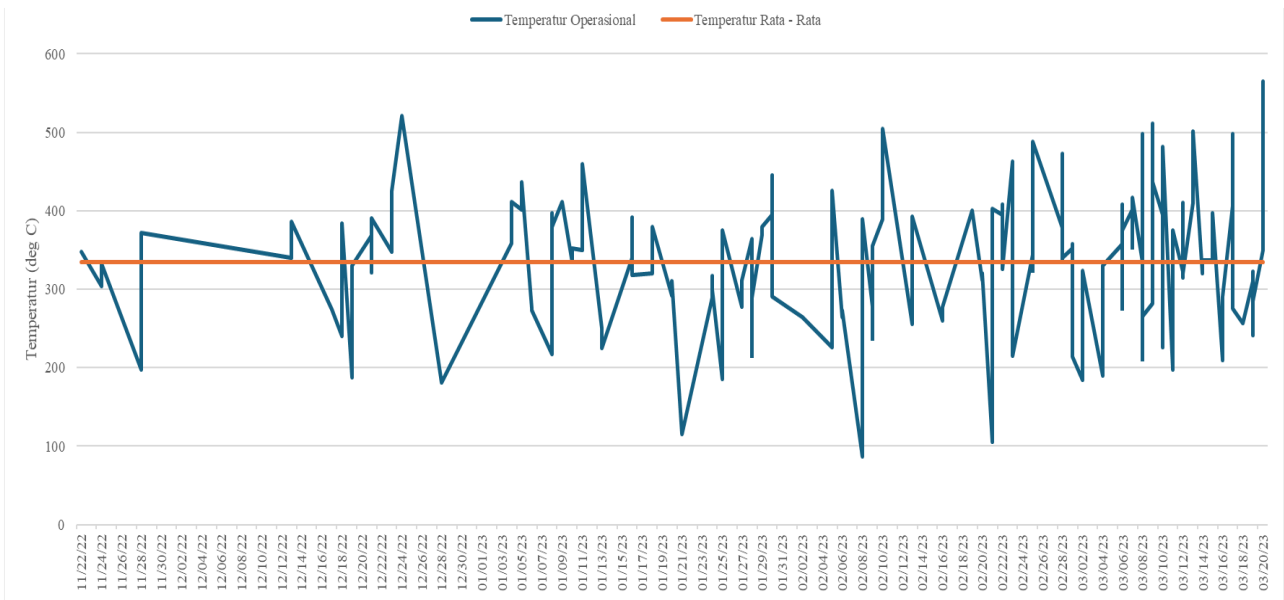
Figure 10. Ladle operating temperature

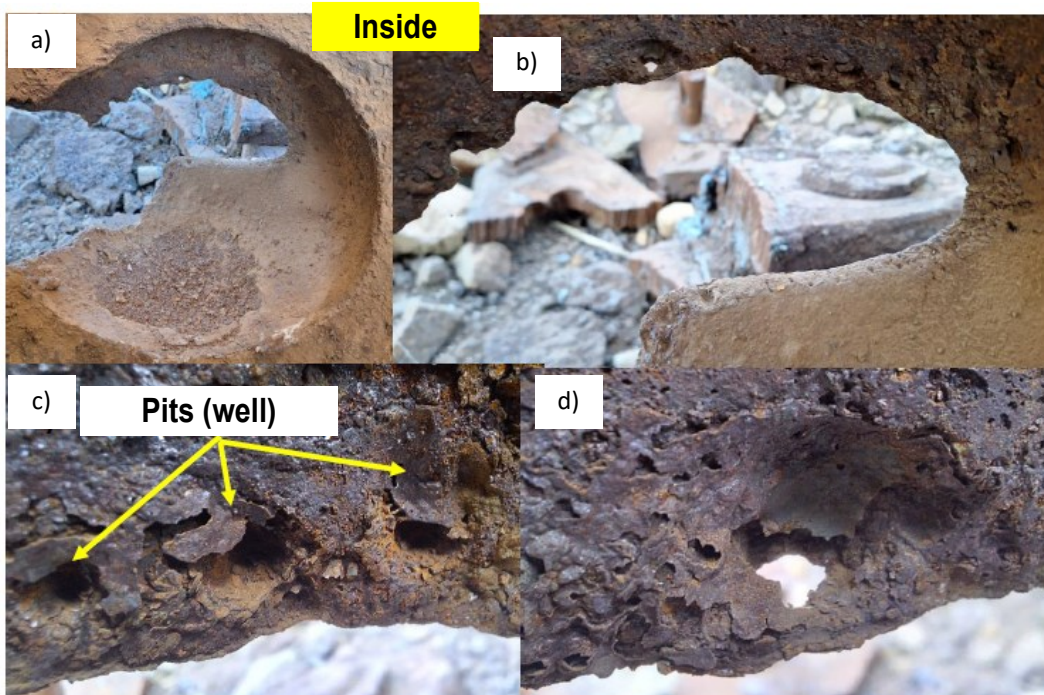
Figure 11. Visual observation of leakage points on ladle; (a) area of failure, (b) presence of multiple pits along the failure area, (c) more detailed visualization of pits, (d) sem – edx test points

The pits formed along the failure area (Figures 11c and 11d) are illustrated below. Some locations exhibit raised features, while others show deep pit formations. The points identified in Figure 11d will subsequently be selected for SEM–EDX analysis to characterize the surface morphology and elemental distribution in the affected region.

extensively; smaller pits coalesce to form larger perforations, as illustrated in Figure 11a. In contrast, reaction (1) does not occur when a sufficiently thick low-nickel converter slag deposit layer is present on the ladle wall (Figure 18).

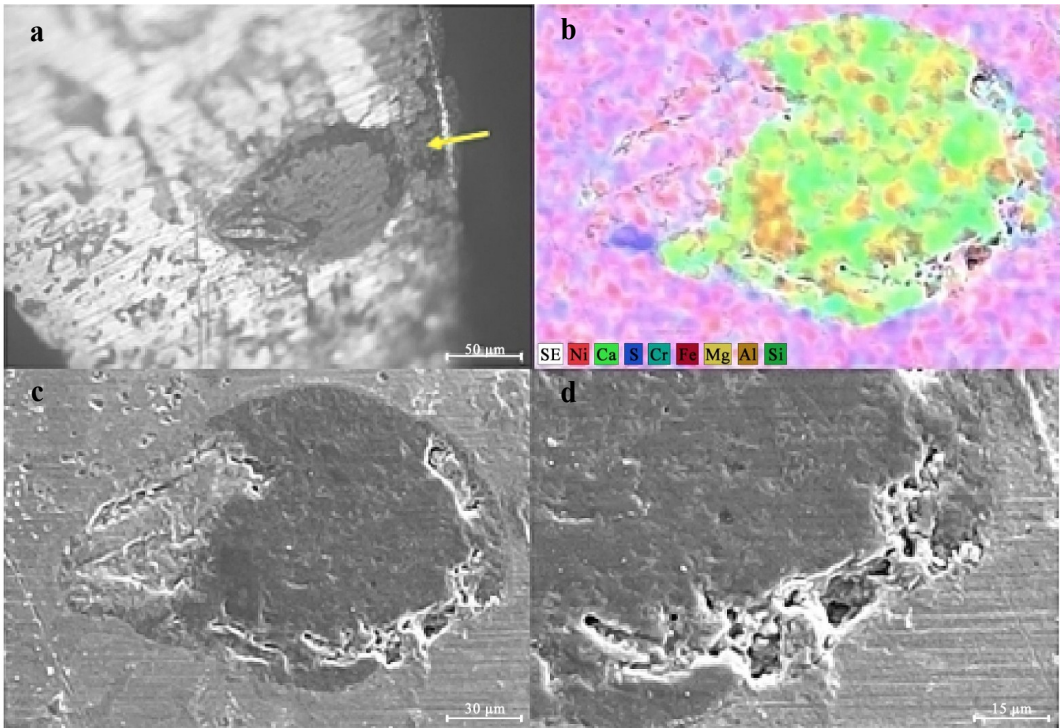
SEM–EDX results (Figures 13 and 14) indicate that the failure area is dominated by non-ferrous

elements, primarily silica and magnesia. However, based on the ladle chemical composition shown in Table 5, silica and magnesia are not constituent elements of the ladle material. Consequently, XRF and XRD analyses were performed on both low-nickel slag and high-nickel slag to test the hypothesis that the silica and magnesia detected in the ladle failure area originated from converter slag.

Figure 13. SEM – EDX test results in the Ladle failure area; (a). Test point with 75x magnification, (b). SEM – EDX results in the test area, ©. Test point with 100x magnification, (d). Test point with 150x magnification

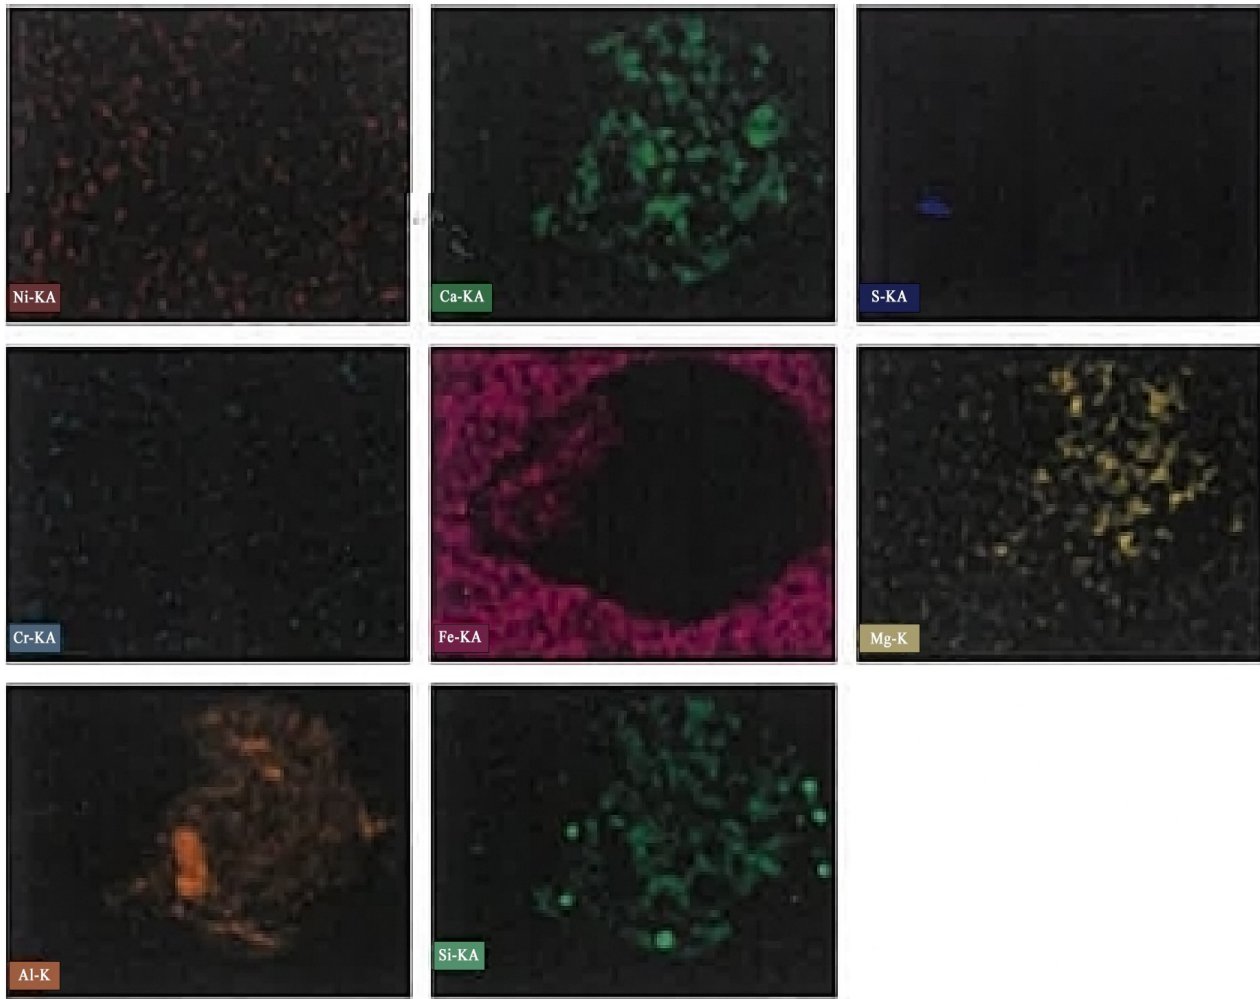
Figure 14. Distribution of elements in the failure zone

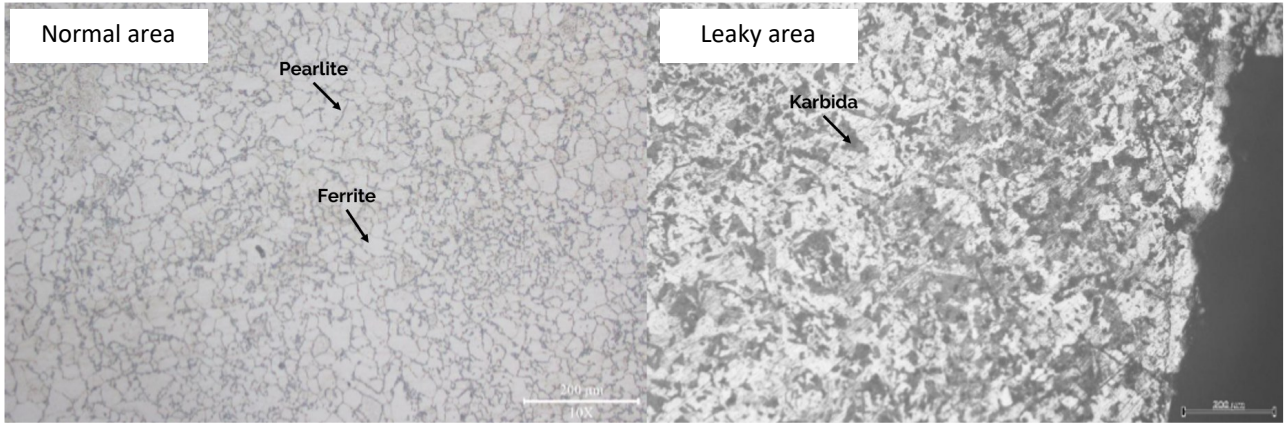
A normal ladle exhibits a microstructure composed of ferrite and pearlite phases, as shown in Figure 4, whereas the failed ladle is dominated by a hard carbide phase. This phase transformation indicates that the failure area was exposed to elevated temperatures (Zheng et al., 2025). In addition to temperature effects, low-nickel slag and high-nickel slag differ significantly in chemical composition. As indicated by the XRD results in

Figure 15. Microstructure between the normal ladle surface (left) and the failed ladle surface (right)

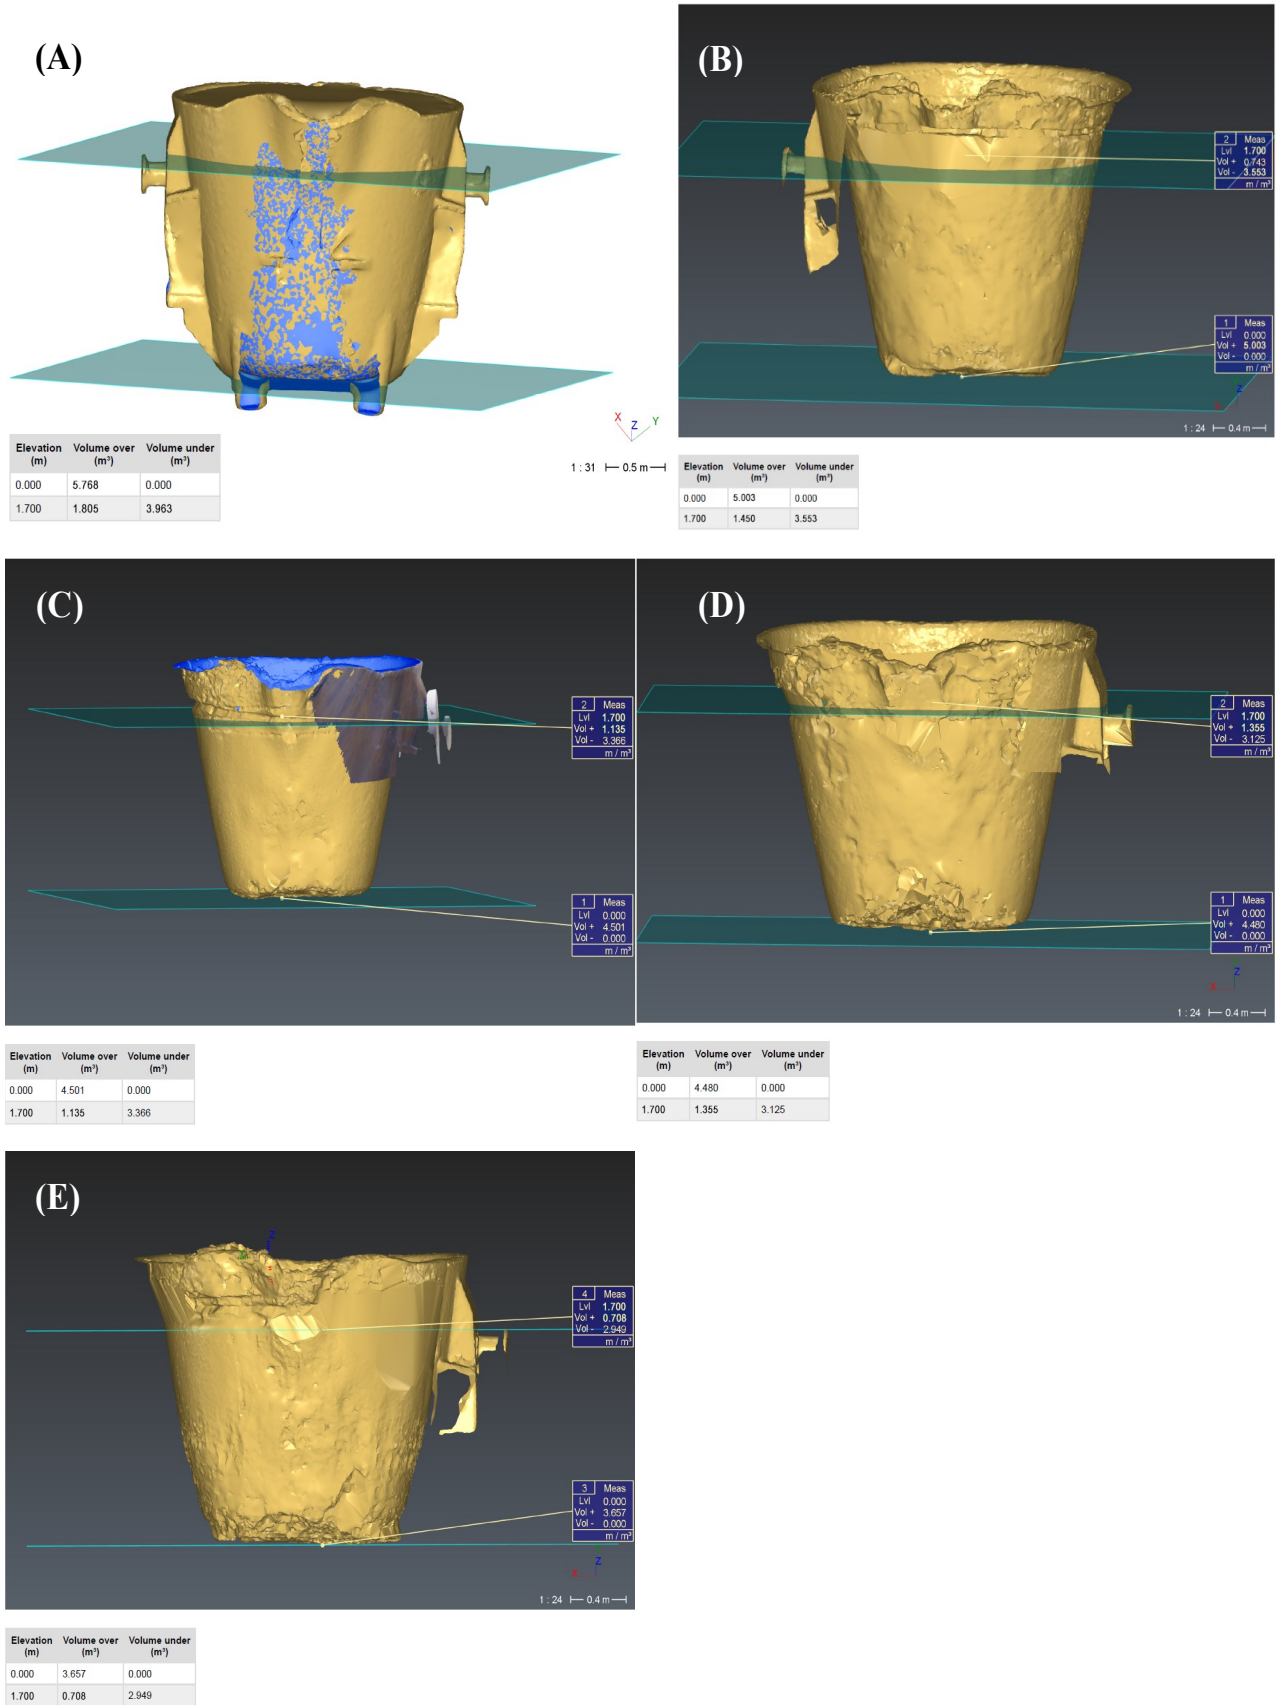
Figure 20. Ladle volume after accommodating low nickel slag converter; (a). First; (b). Second; (c). Third; (d). Fourth; (e) fifth

Table 8 shows that the volume of low-nickel converter slag deposits increases with increasing collection frequency. Excessive deposit thickness can lead to operational issues by reducing the effective capacity for slag or matte and limiting the number of ladles available for operation. Conversely, deposits that are too thin may fail to provide adequate protection and can promote ladle leakage, as discussed in this study. The temperature data measured at each collection stage are presented below.

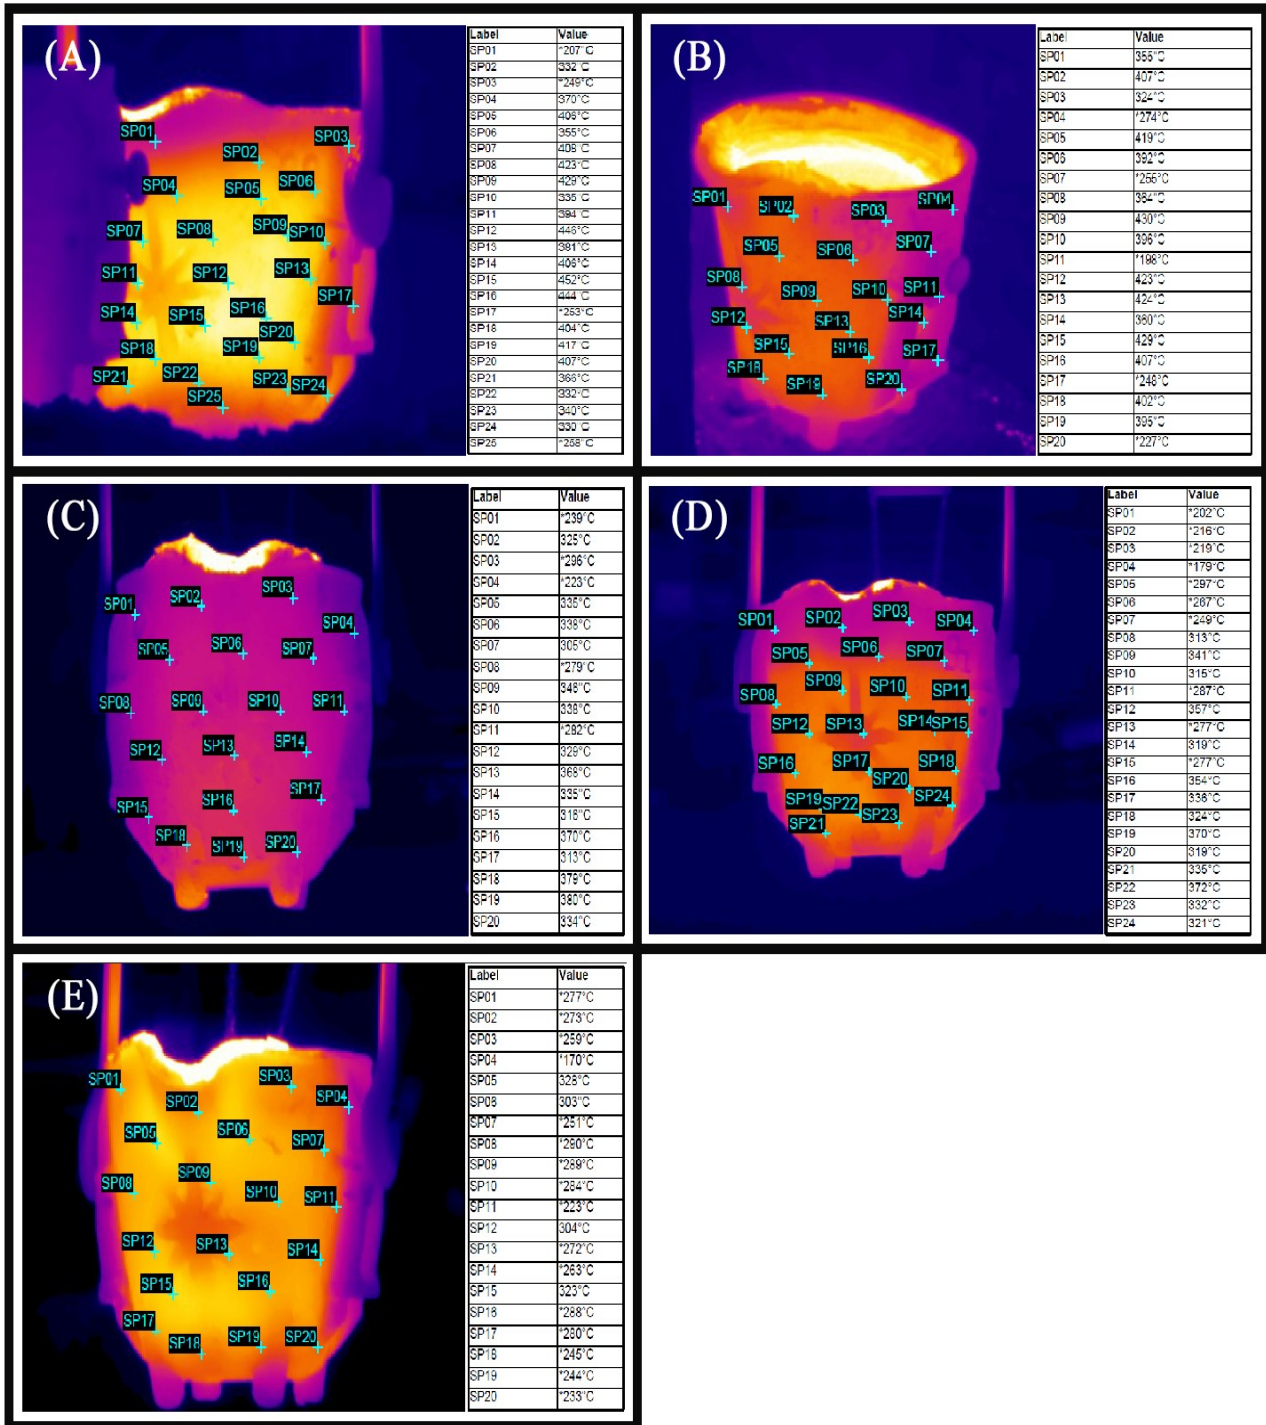
Figure 21. Ladle temperature measurement; (a) first reservoir; (b) second reservoir; (c) third reservoir; (d) fourth reservoir; (e) fifth reservoir

The data in Table 9 indicate that ladle temperature decreases with increasing collection frequency. When correlated with the results in Table 8, this trend demonstrates that a higher volume of low-nickel converter slag deposits contributes to a reduction in overall ladle temperature. Operational data (Figure 10) show that ladles at the company operate at an average maximum wall temperature of approximately 335 °C. Accordingly, the temperature measurements indicate that ladles can safely handle high-nickel converter slag and matte with a low risk of leakage when low-nickel slag collection has reached the fifth cycle. Meanwhile, Figure 21 is a capture from a thermal imaging camera related to measuring the ladle temperature.
