## **Failure Analysis of Ladle Leakage and Wall Deposit Formation with Low-Nickel Slag Converterin Rotary Kiln–Electric Furnace Nickel Smelting (RKEF)**

Fajar Aditya<sup>1</sup>, Sutarsis<sup>1</sup>, and Meyliana Wulandari<sup>2</sup>

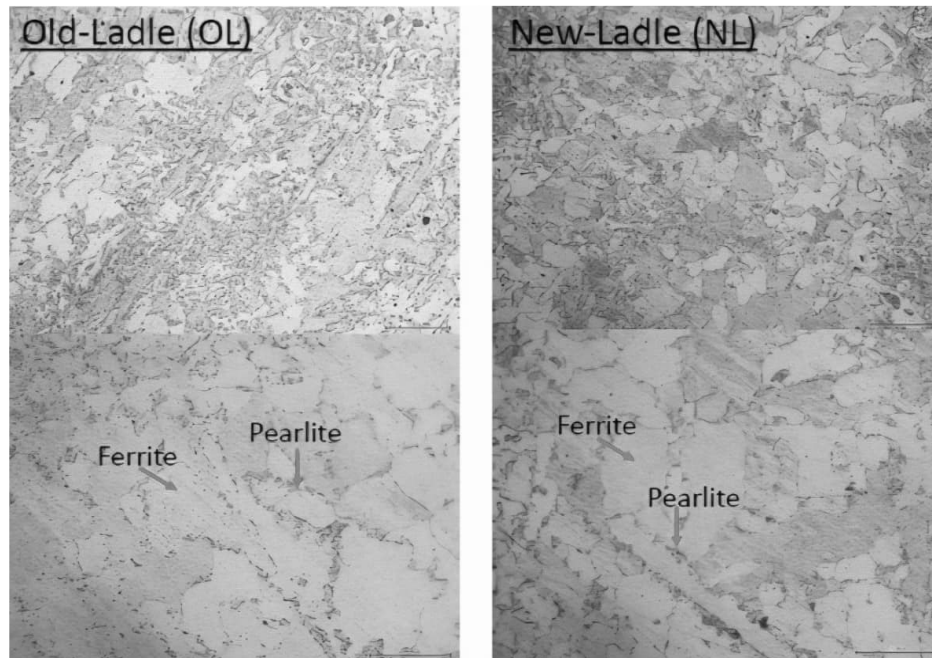
Figure 5. Microstructure of old and new ladle

Figure 5 presents the microstructures of both ladles. In both the old and new ladles, ferrite (light regions) and pearlite (dark regions) are observed. Quantitative analysis shows that the old ladle contains a lower ferrite fraction of approximately 60%, whereas the new ladle exhibits a higher ferrite content of about 75%, with the remaining fraction consisting of pearlite. Ferrite is a soft and ductile phase, while pearlite is comparatively

harder (Steel et al., 2024). These observations are consistent with the chemical composition results in Table 5, as higher carbon content in steel reduces the ferrite fraction and promotes the formation of harder phases such as pearlite. Based on the data presented, both the old and new ladles comply with the company recommendations, which are based on the ASTM A27 Grade 60–30 standard. However, a difference in carbon content is observed between the two ladles, with the old ladle containing 0.28% carbon and the new ladle containing 0.18% carbon. This variation in carbon content is corroborated by microstructural analysis, where the old ladle comprises approximately 60% ferrite and 40% pearlite, while the new ladle consists of about 75% ferrite and 25% pearlite. Additionally, both ladles exhibit comparable mechanical properties, as summarized in Table 6.

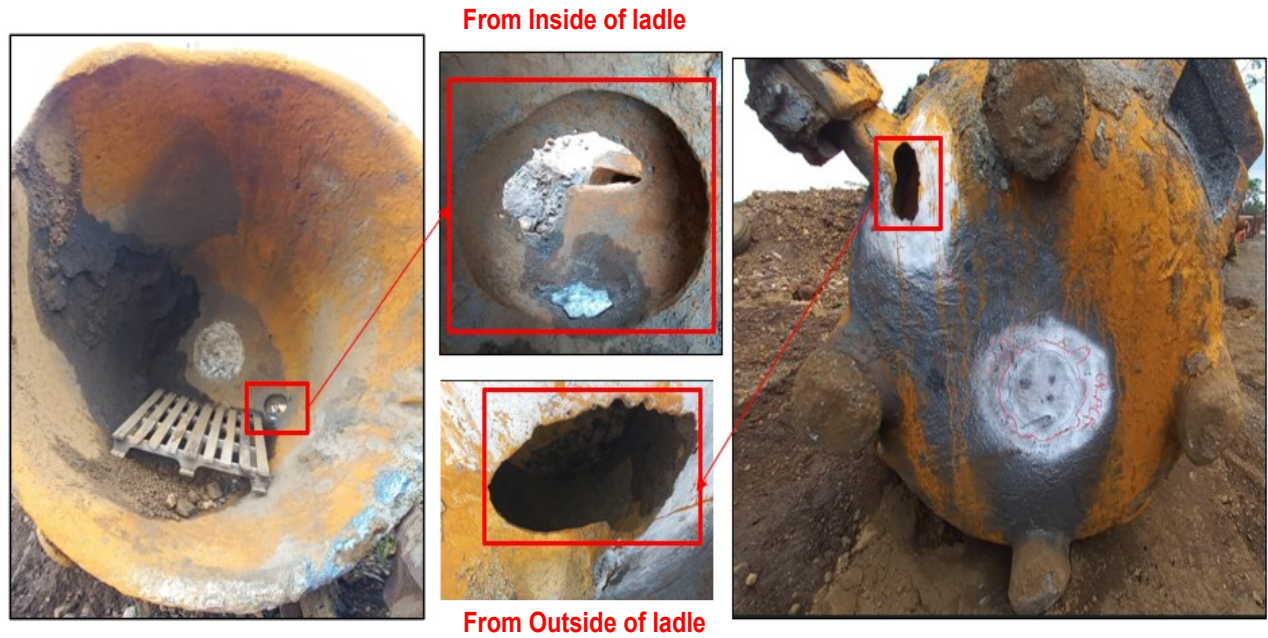
Figure 6. Visual observation of ladle leaking from inside and outside

Immediately after the ladle leak incident, an investigation was conducted to document and analyze the ladle leak point (Figure 6).

The thin deposit of low-nickel converter slag allowed penetration by the high-nickel converter slag during pouring due to its higher temperature (approximately 1220 °C for high-nickel slag compared to 1200 °C for low-nickel slag). In the failure area, a pit was also observed that formed from the internal surface (Figure 11), indicating that the ladle failure originated from inside.

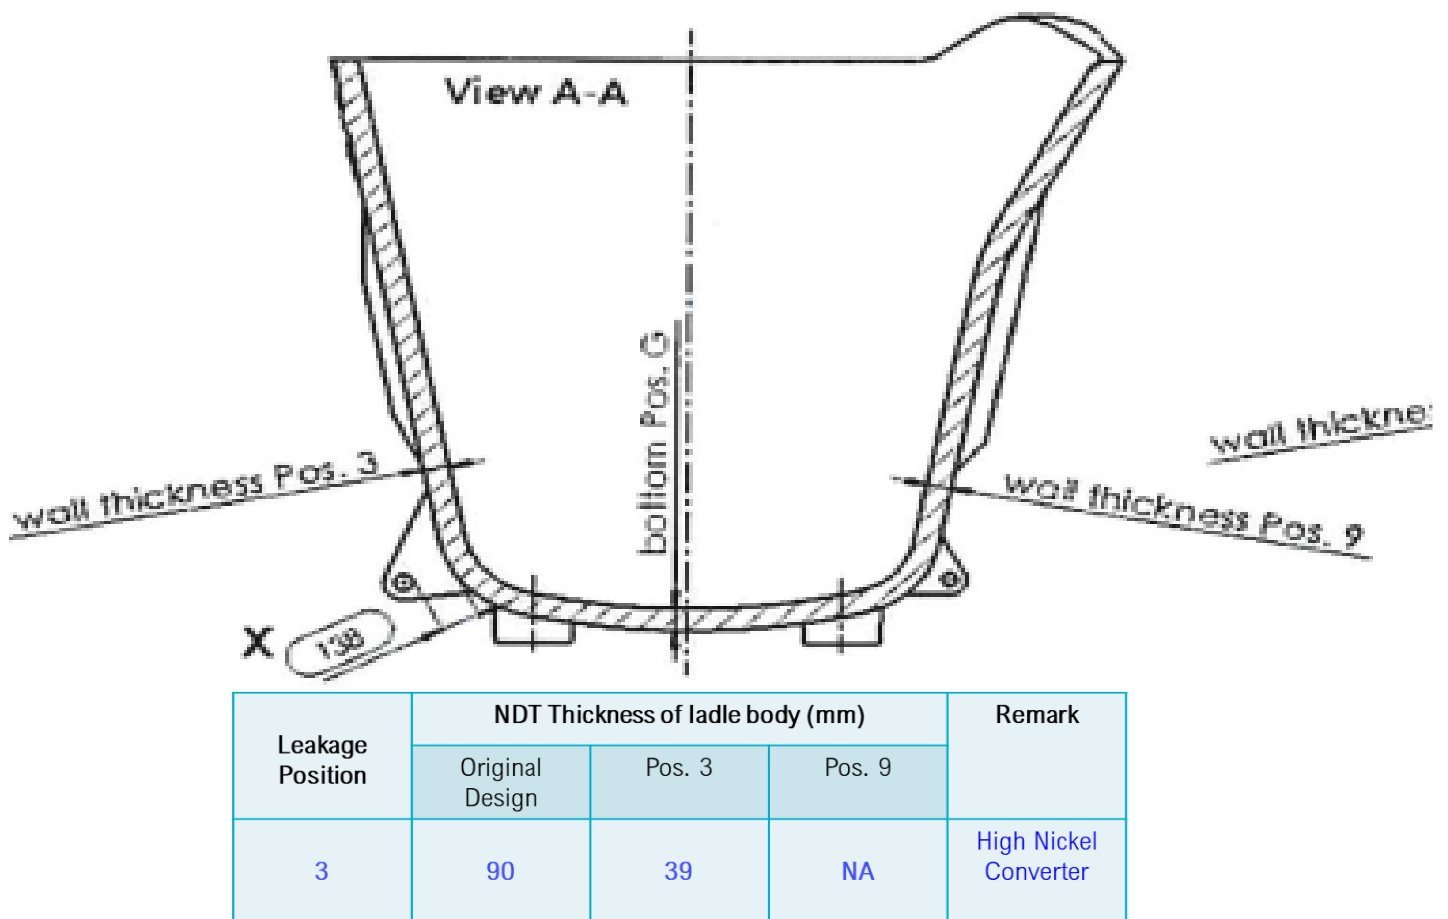
Figure 7. Leakage point in ladle and its thickness

Figure 7 indicates that the ladle thickness in the leaking area has been reduced to 39 mm from its original thickness of 90 mm. This region is particularly susceptible to high mechanical loads from slag and matte during the pouring process from the converter, as illustrated in Figure 8. In addition to the mechanical load concentrated in the ladle hook area during the initial slag pouring from the converter, it was observed that the low-nickel converter slag deposit within the ladle was relatively thin.

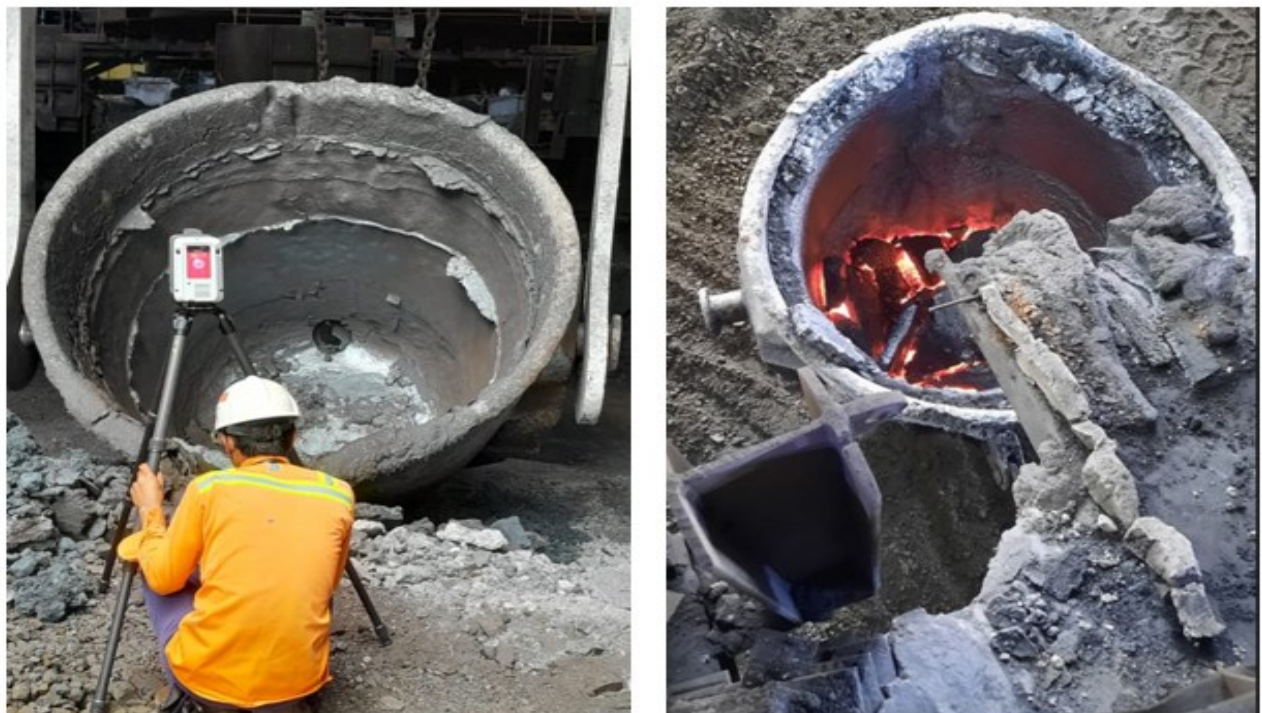
Figure 9. Converter slag deposit on the wall of a leaking ladle (left) with another ladle (right)

Visually, the deposits in the leaking ladle (Figure 9, left) differ significantly in thickness compared to those in normal ladles (Figure 9, right). This difference is further reflected in the ladle temperature at the time of the incident, which reached 565 °C, considerably higher than the average operating temperature of 335 °C (Figure 10).

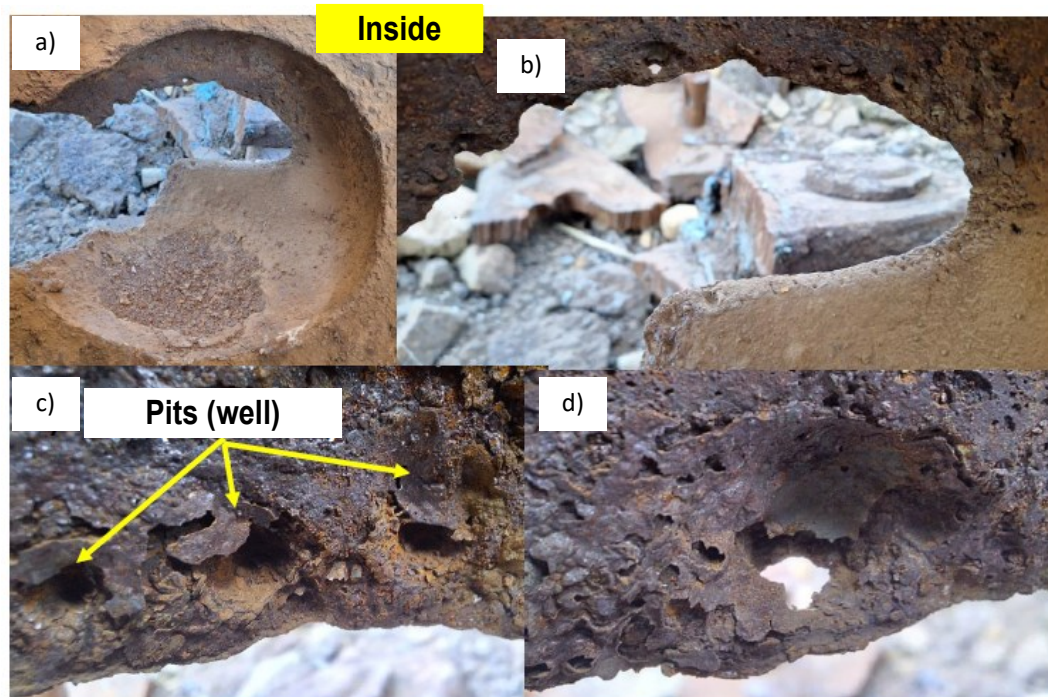
Figure 11. Visual observation of leakage points on ladle; (a) area of failure, (b) presence of multiple pits along the failure area, (c) more detailed visualization of pits, (d) sem – edx test points

The pits formed along the failure area (Figures 11c and 11d) are illustrated below. Some locations exhibit raised features, while others show deep pit formations. The points identified in Figure 11d will subsequently be selected for SEM–EDX analysis to characterize the surface morphology and elemental distribution in the affected region.

extensively; smaller pits coalesce to form larger perforations, as illustrated in Figure 11a. In contrast, reaction (1) does not occur when a sufficiently thick low-nickel converter slag deposit layer is present on the ladle wall (Figure 18).

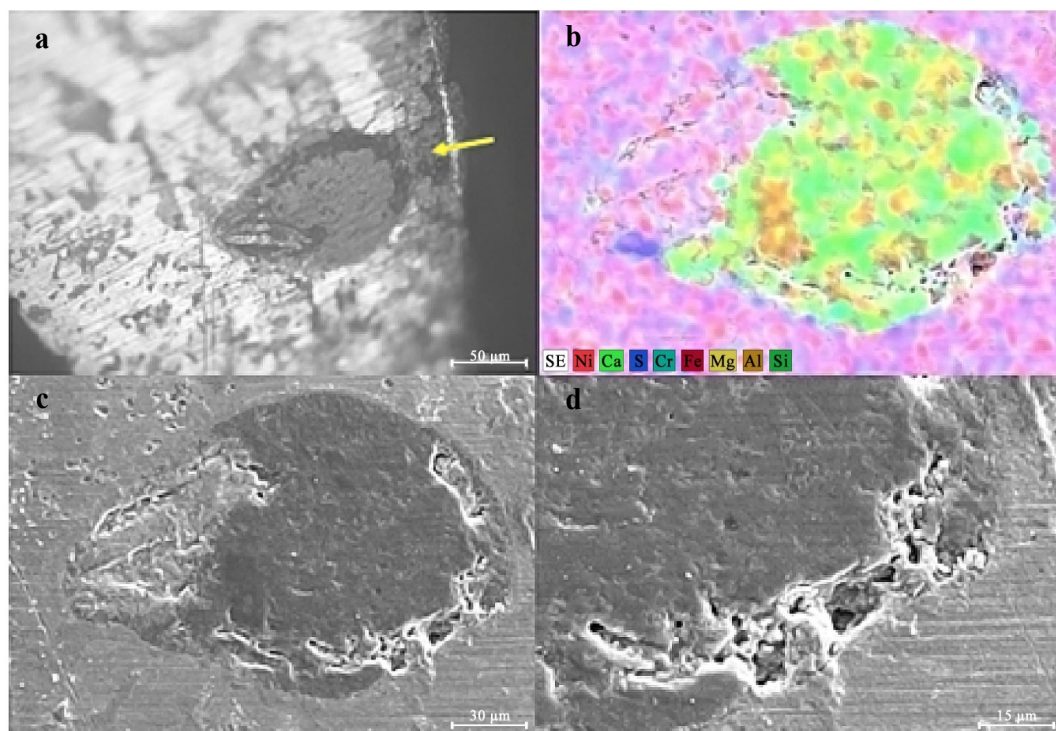
Figure 13. SEM – EDX test results in the Ladle failure area; (a). Test point with 75x magnification, (b). SEM – EDX results in the test area, ©. Test point with 100x magnification, (d). Test point with 150x magnification

SEM–EDX results (Figures 13 and 14) indicate that the failure area is dominated by non-ferrous

elements, primarily silica and magnesia. However, based on the ladle chemical composition shown in Table 5, silica and magnesia are not constituent elements of the ladle material. Consequently, XRF and XRD analyses were performed on both low-nickel slag and high-nickel slag to test the hypothesis that the silica and magnesia detected in the ladle failure area originated from converter slag.

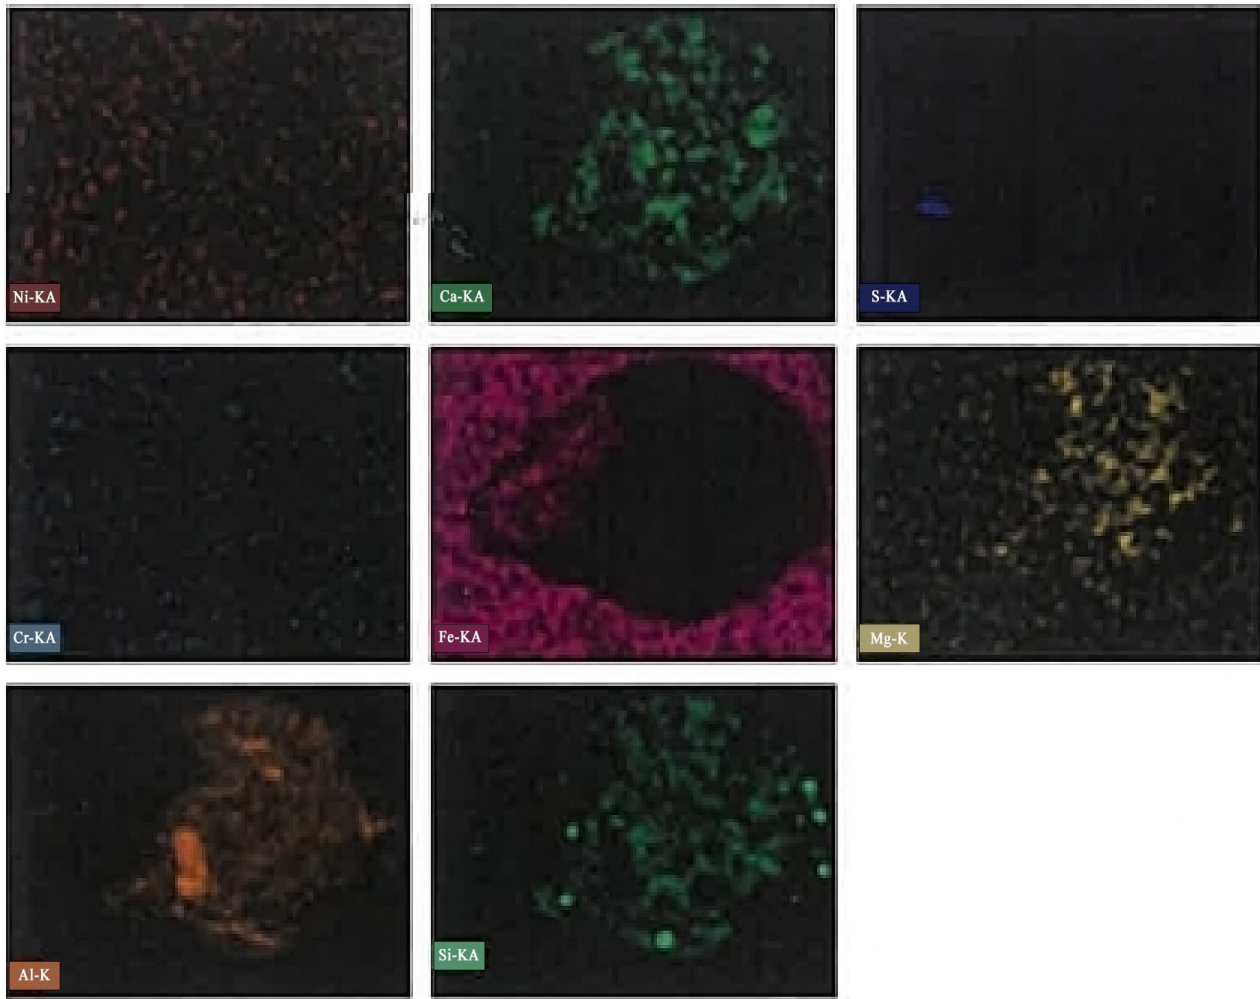
Figure 14. Distribution of elements in the failure zone

Greater oxidation of Fe to FeO leads to a progressive reduction in ladle mass and wall thickness in the affected area. This interpretation is supported by SEM–EDX results, which show a significant decrease in iron (Fe) content at the failure location, accompanied by a uniform distribution of nickel (Ni). The oxidation of Fe to FeO is further evidenced by the formation of pits along the failure zone (Figures 11 and 12). With continued contact between the high-nickel converter slag and the ladle wall, these pits develop

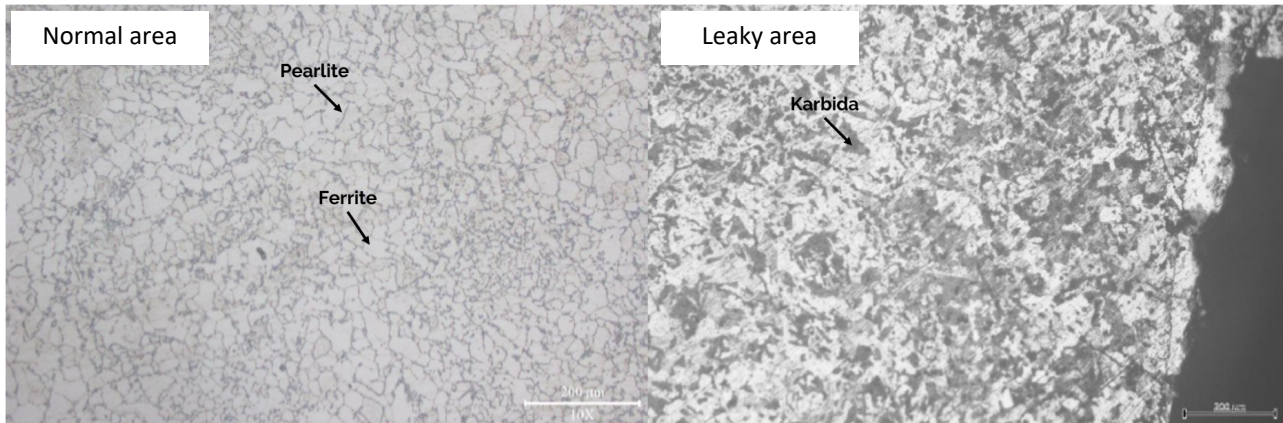
Figure 15. Microstructure between the normal ladle surface (left) and the failed ladle surface (right)

A normal ladle exhibits a microstructure composed of ferrite and pearlite phases, as shown in Figure 4, whereas the failed ladle is dominated by a hard carbide phase. This phase transformation indicates that the failure area was exposed to elevated temperatures (Zheng et al., 2025). In addition to temperature effects, low-nickel slag and high-nickel slag differ significantly in chemical composition. As indicated by the XRD results in

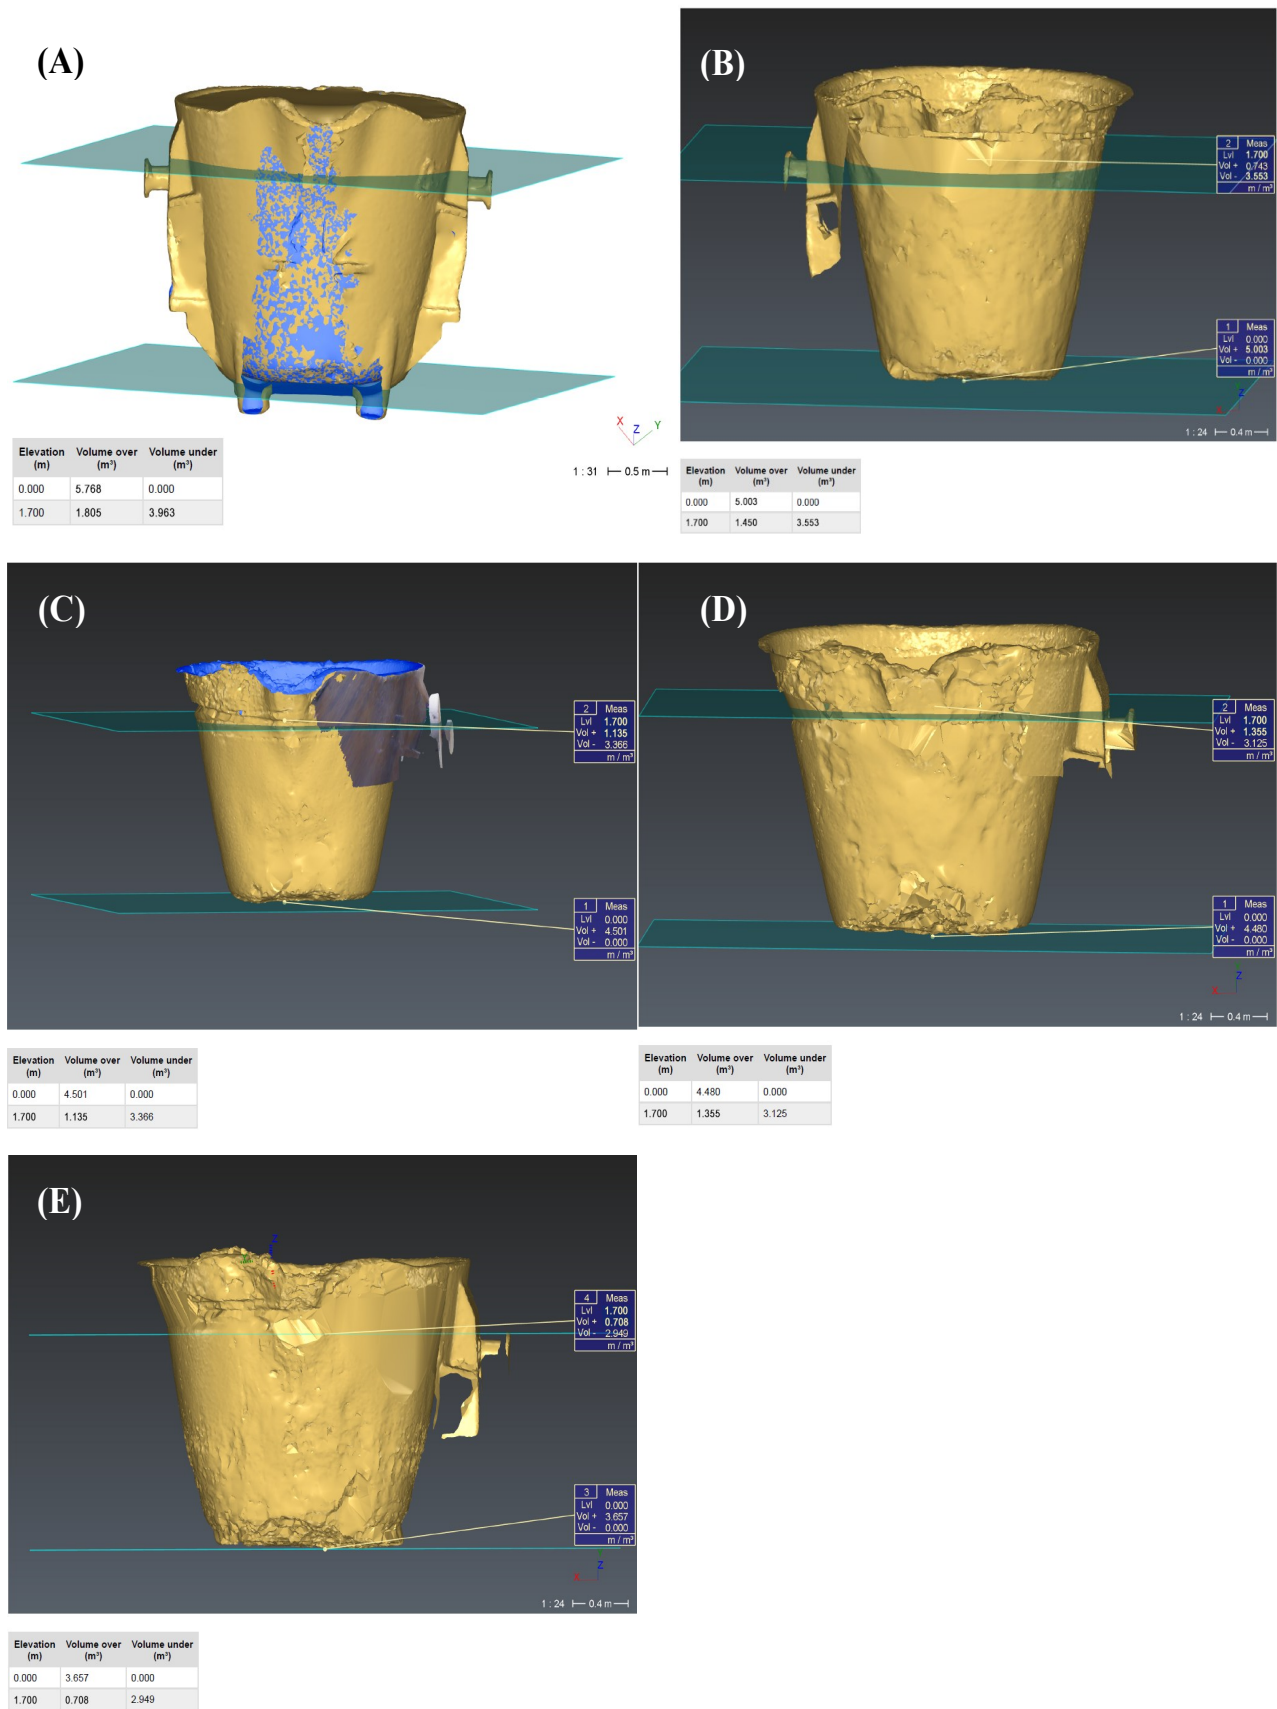
Figure 20. Ladle volume after accommodating low nickel slag converter; (a). First; (b). Second; (c). Third; (d). Fourth; (e) fifth

Table 8 shows that the volume of low-nickel converter slag deposits increases with increasing collection frequency. Excessive deposit thickness can lead to operational issues by reducing the effective capacity for slag or matte and limiting the number of ladles available for operation. Conversely, deposits that are too thin may fail to provide adequate protection and can promote ladle leakage, as discussed in this study. The temperature data measured at each collection stage are presented below.

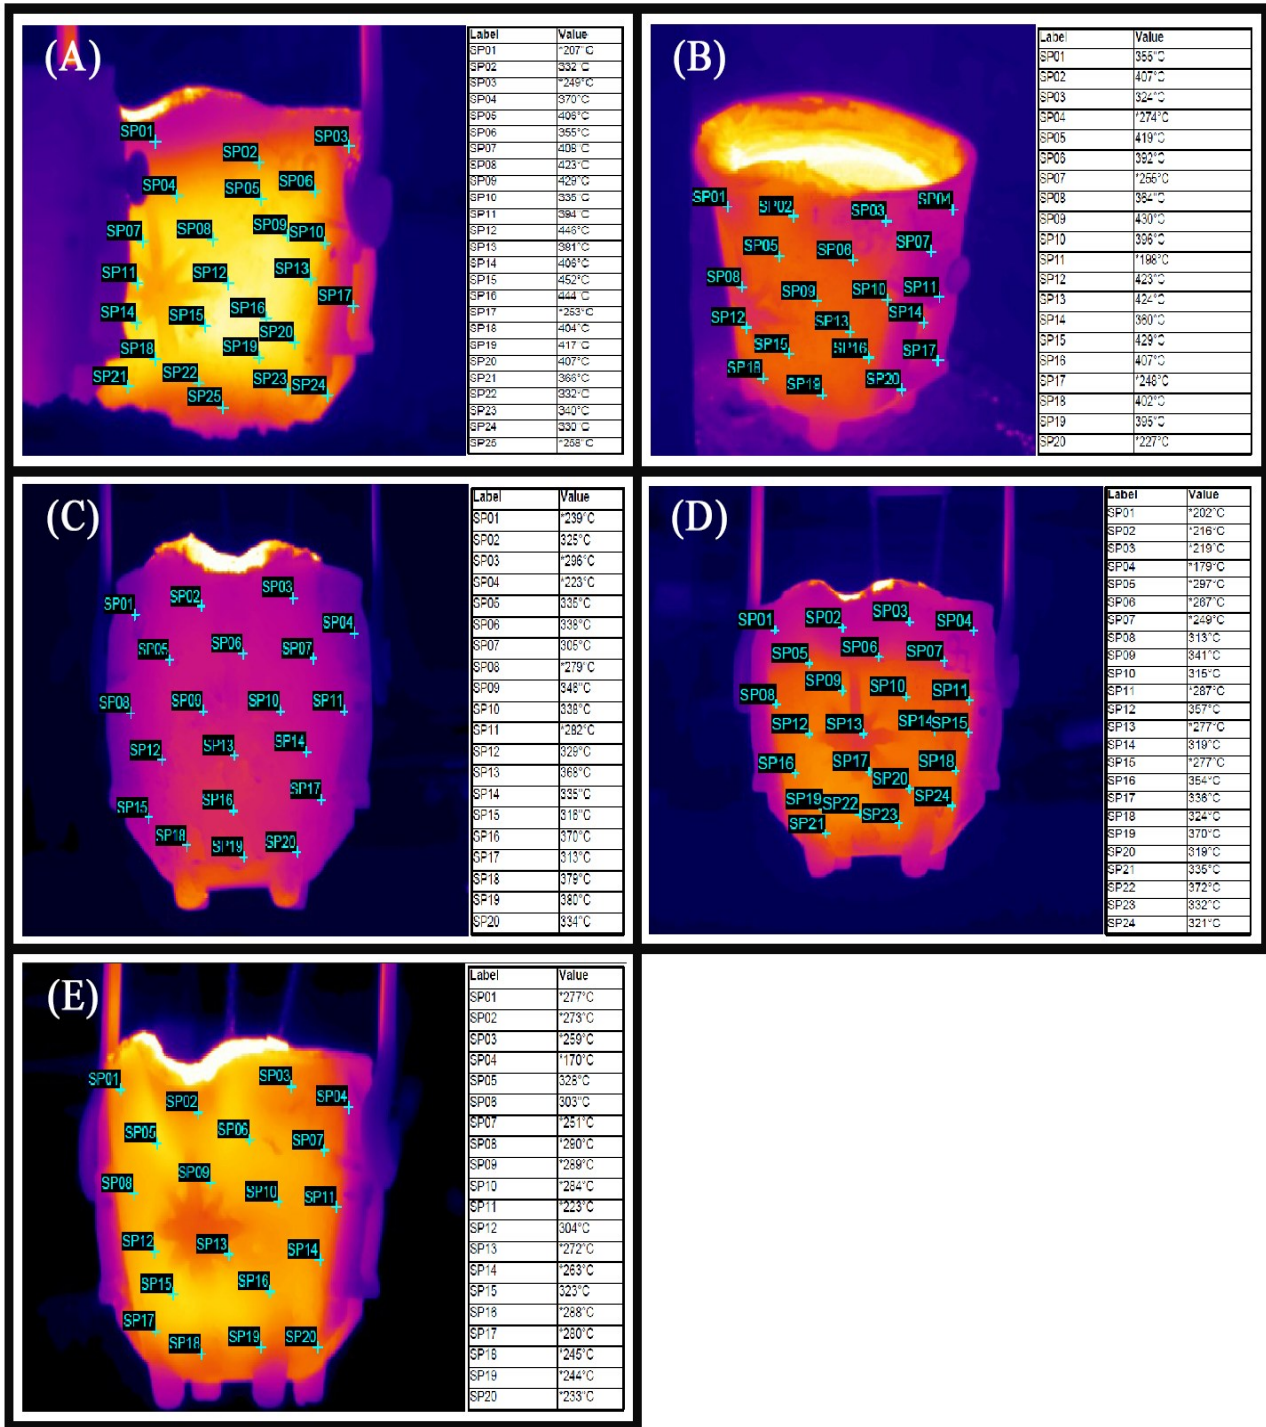
Figure 21. Ladle temperature measurement; (a) first reservoir; (b) second reservoir; (c) third reservoir; (d) fourth reservoir; (e) fifth reservoir

The data in Table 9 indicate that ladle temperature decreases with increasing collection frequency. When correlated with the results in Table 8, this trend demonstrates that a higher volume of low-nickel converter slag deposits contributes to a reduction in overall ladle temperature. Operational data (Figure 10) show that ladles at the company operate at an average maximum wall temperature of approximately 335 °C. Accordingly, the temperature measurements indicate that ladles can safely handle high-nickel converter slag and matte with a low risk of leakage when low-nickel slag collection has reached the fifth cycle. Meanwhile, Figure 21 is a capture from a thermal imaging camera related to measuring the ladle temperature.
