STUDY ON COMPONENTS RATING OF GASOLINE ENGINE AS A PERFORMANCE QUALITY INDICATOR OF LEMIGAS FORMULATED API SL LUBRICANT

ABSTRACT

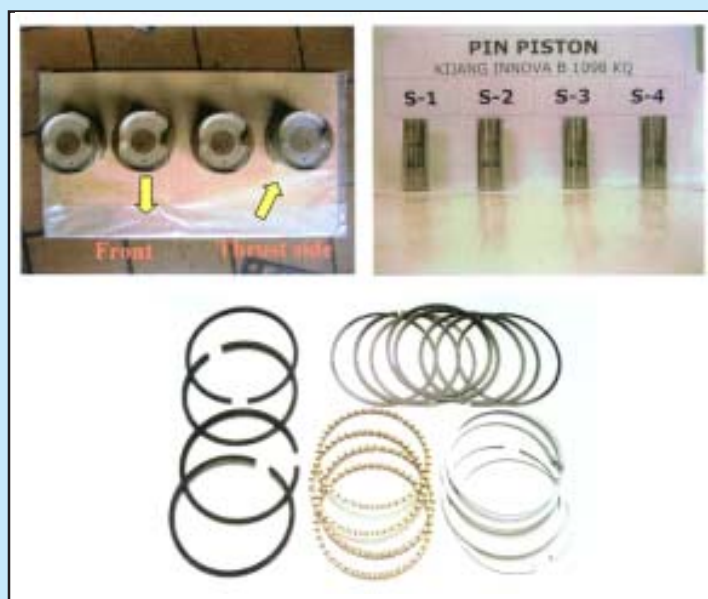
Figure 1
Piston thrust side, pin piston and ring piston

Piston set consists of a piston, piston pin and piston ring pairs (Figure 1). Rating of pistons was made

on the new set and the end of the road test (15,000 km), i.e. the diameter of the piston and the wear marks, particularly on his side thrust. Piston pin diameter was measured to determine wear of the piston pin. Cracks on the piston and piston ring liner (ring gap) were measured to determine the wear after 15,000 km usage. Piston rings, particularly compression (ring no.1 and no. 2), were weighed to determine the wear ring after 15,000 km.

Occurrence of wear of the piston sets can lead to reduced ability of machines to produce maximum energy. Results of analysis of the four piston ratings show the same dimension values before and after the road test. Good lubrication performance can reduce friction thereby reducing wear of metals.

Analysis of the piston pin was carried out to know weight loss after implementation of the road test. Piston pin weight losses are very small namely is an average of 0.0015 grams, so the value of the wear on the piston pin is considered normal. Visually on the piston pin there are no visible hot spots (bluish color) that indicate the occurrence of inter-metal touches.

Engine piston ring is a component that serves as seal between the combustion chamber with the lubricants crankcase (Figure 1). A load charge received by the piston ring is usually very high so that dimensional changes occur and the wear is an important parameter that must be observed. The results show that there is wear of the piston ring, indicated by the occurrence of weight loss. Average weight loss of each piston ring amounted

to 0.001 grams (R.1), 0.00125 grams (R.2) and 0 grams (R.3), or not more than 0.032%-wt.

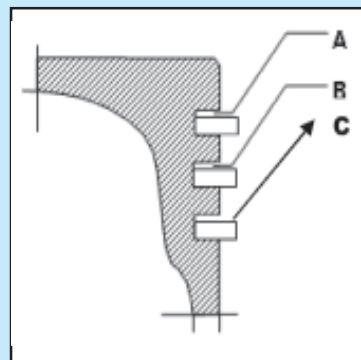
Figure 2
Piston ring side clearance

This parameter is a measure of the spatial dimension of piston ring placement (Figure 2). This value is analyzed to determine deposit formation tendency of the ring-land which resulted in ring-sticking. The results show that the ring-side clearance is still in good condition and remain until the end of the road test, which is 0.03 mm for ring A, 0.03 mm for ring B and 0.05 mm for ring C. Ring condition of the piston ring has a value rating of 10, indicating there is no ring sticking.

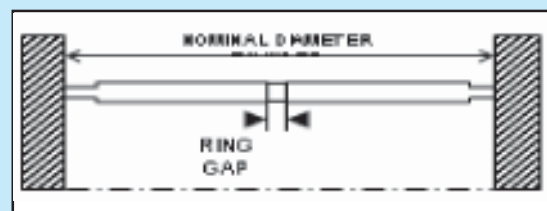
Figure 3
 Ring gap measurement

The occurrence of wear and tear can cause the ring-gap increases (Figure 3) so that engine compression will decrease. Results showed that the ratings gap on all four-ring pistons remained on average the same until the end of the road test (Table 1).

Piston ring conditions that remain good shows that the lubricating oil performance provide lubrication so well that the wear can be minimized. This was also detected from the engine compression pressure test

showed no change, i.e. 5.11 bar. Compression pressure that remains good will indicate the condition of the combustion chamber is still in accordance with standard conditions, so that the engine is able to provide optimum performance.

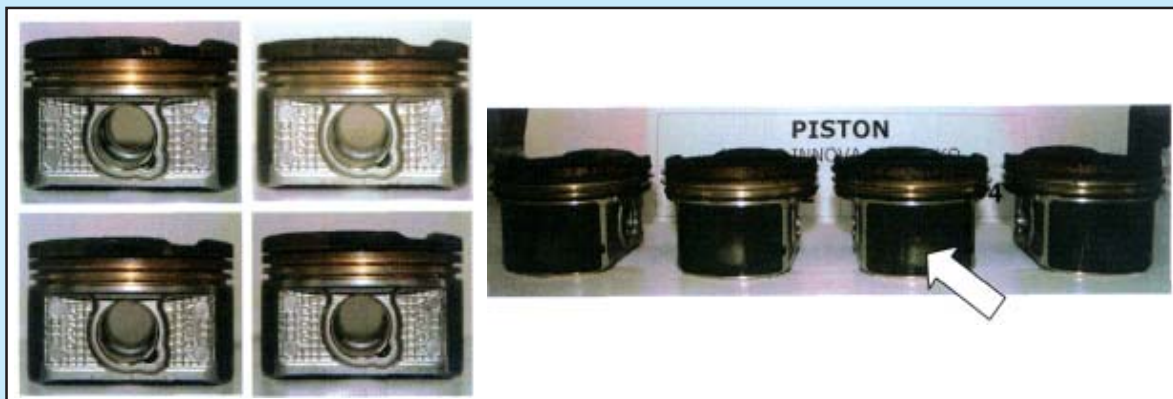
Figure 4
 Piston condition (Skirt Varnish)

Piston skirt varnish rating results show that the value of the component ratings are satisfactory to meet the ILSAC GF-3 Sequence IIIF, the 9.0 minimum. It is also apparent in the physical condition of the pistons that are clear of deposits and varnish (Figure 4). Piston skirt are in good condition with a value rating of 9.5 that indicates the condition of the wear

on piston skirts, especially the thrust side only at trace levels.

The results on the skirt varnish and deposits that formed on the piston shows characteristics of some parameters of the condition of the piston component after the execution of road tests (Table 2).

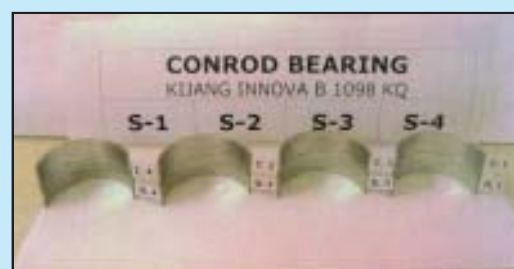
Figure 5
Connecting rod Bearing Kijang Innova 2006

also high. The results on the connecting rod bearing components showed that almost no wear has occurred during the test road mileage to 15,000 km. Some little loss of material was detected from the top of connecting rod bearing and below-average <0.01 grams (Figure 5). The value of weight loss is still within safe and passes the test based on performance test ILSAC GF-3 Seq. VII for API SL, at a maximum of 0.0246 grams (Table 3).

Wear of bearings is a common phenomenon that occurs in engine operation. However, the wear should not exceed the maximum limit value. Analysis of the wear pads are made with the lost weight calculation shows that the some bearing weight loss has occurred during the road test. The magnitude of weight loss is only 0.010 grams, less than the maximum limit of 0.0264 grams (Table 8). This means that it still meets the specifications set forth in sequence VII.

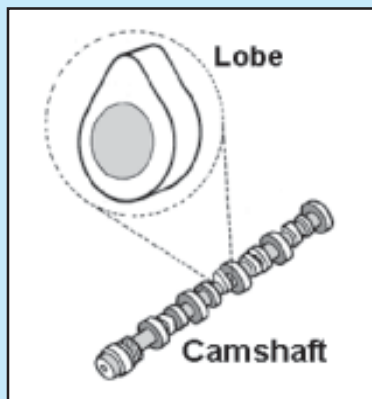
Figure 6
 Camshaft

This is an important engine component part which is used as one of the objects of observation and study (Figure 6). The results on the camshaft components showed that during road tests little wear has occurred despite the limitation value which is still very safe. The result of the camshaft lobe rating average is 0.001 mm on the inlet and the outlet of 0.002 mm (Table 4). Wearable of the maximum allowable under the standard test of ILSAC GF-3 Seq. IVA amounted to 0.12 mm so that the wear of the camshaft after 15,000 km mileage is still far below the specified maximum wear limit.

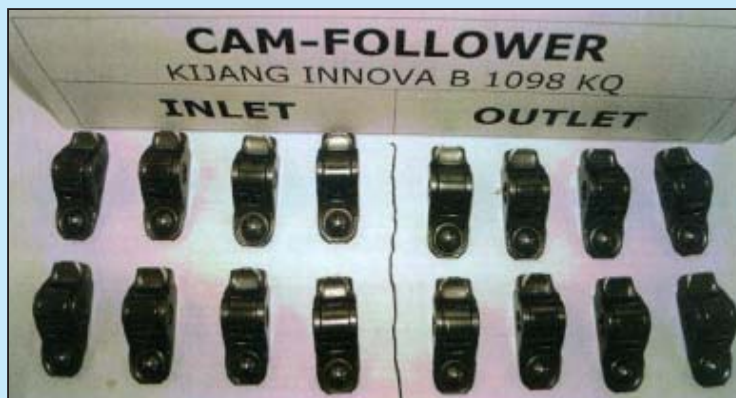
Figure 7
 Camshaft follower condition after road-test

Camshaft follower is a component that was analyzed in the ratings (Figure 7). Measurements taken on the dimensions of the camshaft follower shows that there is no wear and tear on these components (Table 5). ILSAC GF-3 tests Sequence IIIF provide maximum limit wear of the camshaft follower of 0.002 mm.

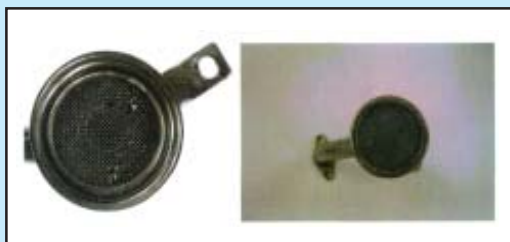
Figure 8
Oil Screen Kijang Innova 2006

Oil screen is very important component to ensure the cleanliness of lubricating oil that circulates in the engine is in clean condition (Figure 8). Analyses of these components are conducted to determine whether there is a blockage or are still in good condition. This parameter can be found by doing an oil screen weighing. The results show that the condition of oil and the screen still does not show blockages. This is detected from the result of oil weighing a fixed screen, which is 279.84 grams. This is in accordance with the restrictions in the standard test sequence VG ILSAC GF-3, which should not happen in the oil screen clogging.

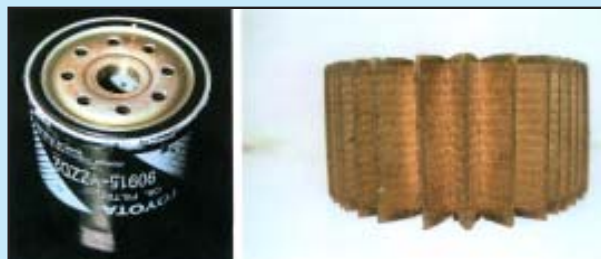
Figure 9
Oil filter

Oil filter function is to filter out the impurities brought by the lubricating oil (Figure 9). Oil filters, does its function to filter sludge, dust and metal wear. Blockage on the lubricating oil filter may cause the lubricant not to circulate properly so as not to be capable of providing excellent lubrication performance. The results show the existence of impurities retained on the filter, amounting to 2.62 grams. This amount is classified as very small and not to cause filter clogging, so it is still safe to use.

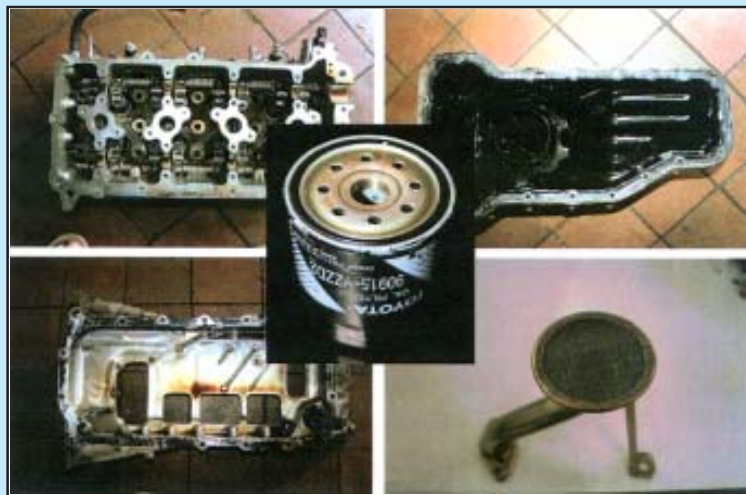
Figure 10
 Sludge and varnish formation

Sludge and varnish formation is a condition that may interfere with the performance of vehicle engine lubrication. Analysis of sludge and varnish formation on the crankcase oil pan, a living dead zone camshaft, valve cover, oil pump strainer and oil filter (Figure 10). The results show that there is no formation of sludge and varnish formed so that in general these components are in clean condition (Table 6).
