## **Failure Analysis of Ladle Leakage and Wall Deposit Formation with Low-Nickel Slag Converterin Rotary Kiln–Electric Furnace Nickel Smelting (RKEF)**

Fajar Aditya<sup>1</sup>, Sutarsis<sup>1</sup>, and Meyliana Wulandari<sup>2</sup>

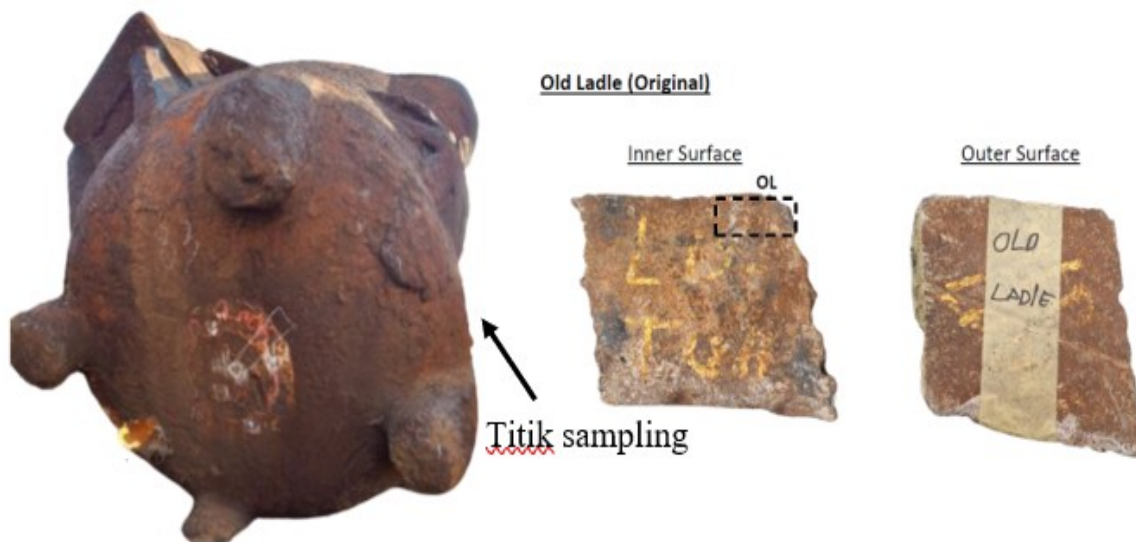
Figure 3. Old ladle sampling point

Failure analysis of the ladles was conducted through microstructural examination using an optical microscope and surface morphology analysis using SEM–EDX. In addition, phase identification and chemical characterization of the slag were performed using XRD and XRF on low-nickel and high-nickel converter slag samples. The analysis of low-nickel converter slag deposit formation inside the ladle was carried out through a series of slag-holding trials up to the fifth cycle. During each holding cycle, the ladle wall temperature was measured using a thermal imaging camera, while deposit volume was determined using a LiDAR camera and calculated based on differences volume before and after measurement. To support this study, samples were collected from both old and new ladles from the nickel smelting industry. Figure 3 shows a sample from the old casting mold taken from the outer wall of the mold.

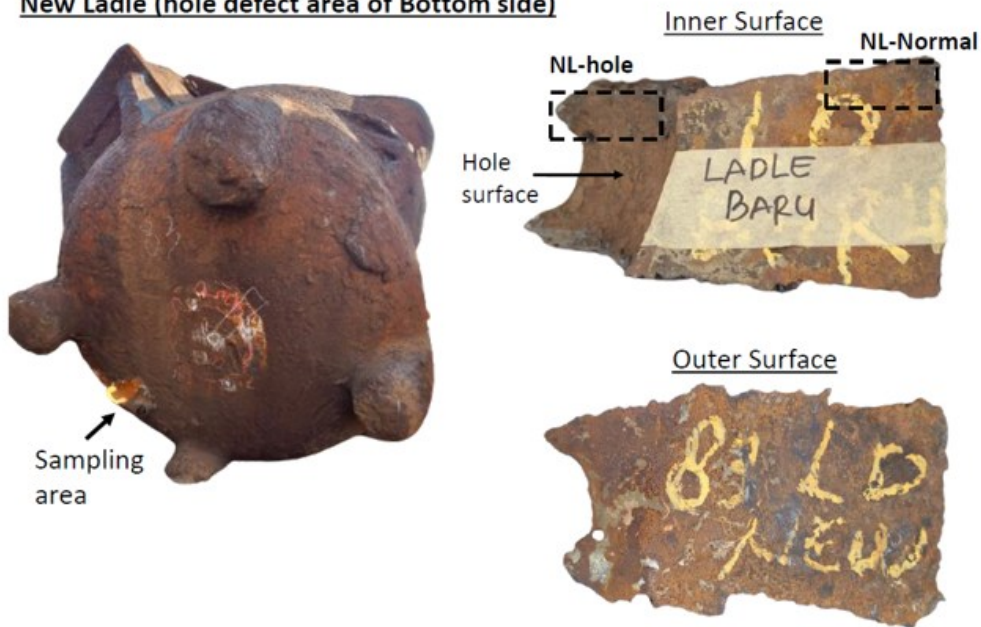
Figure 4. New ladle and leaking ladle sampling points

Figure 4 shows samples from a new casting mold and a damaged casting mold, taken from the same mold but from different locations. The sample from the new casting mold was taken from an undamaged section, while the sample from the damaged casting mold was taken directly from the area where the leak occurred.

**New Ladle (hole defect area of Bottom side)**

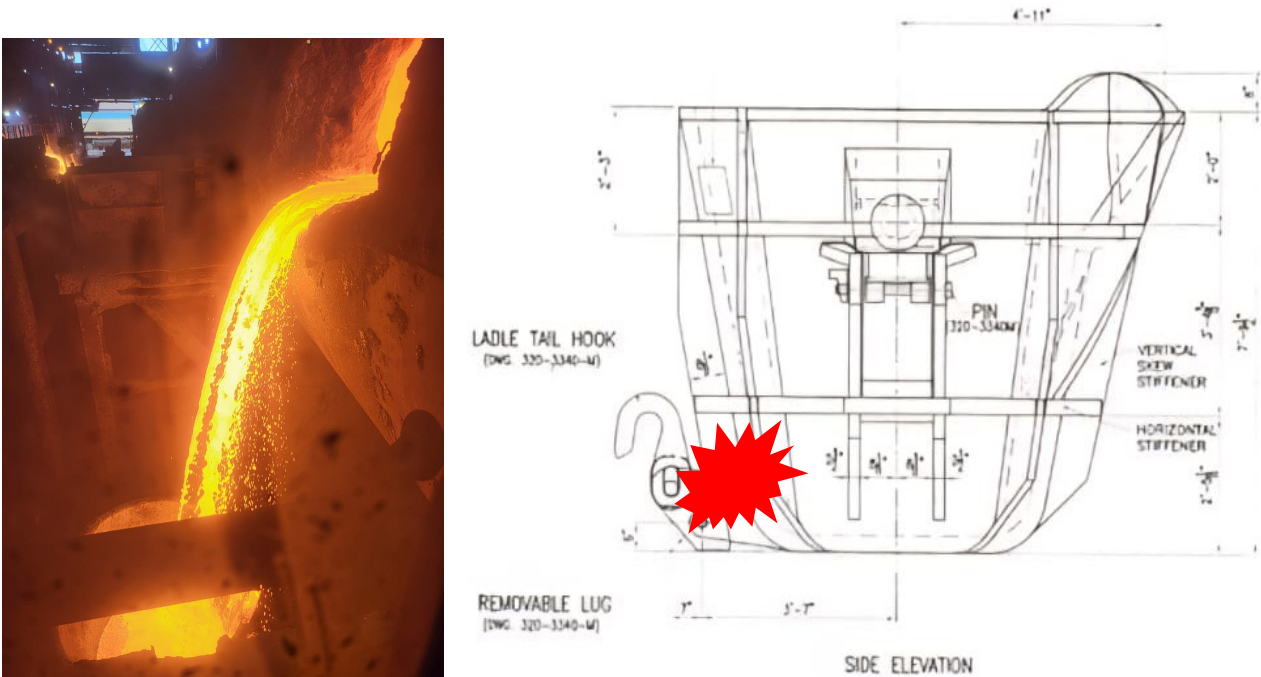
Figure 8. Slag pouring scheme from converter to ladle

Figure 7 indicates that the ladle thickness in the leaking area has been reduced to 39 mm from its original thickness of 90 mm. This region is particularly susceptible to high mechanical loads from slag and matte during the pouring process from the converter, as illustrated in Figure 8. In addition to the mechanical load concentrated in the ladle hook area during the initial slag pouring from the converter, it was observed that the low-nickel converter slag deposit within the ladle was relatively thin.

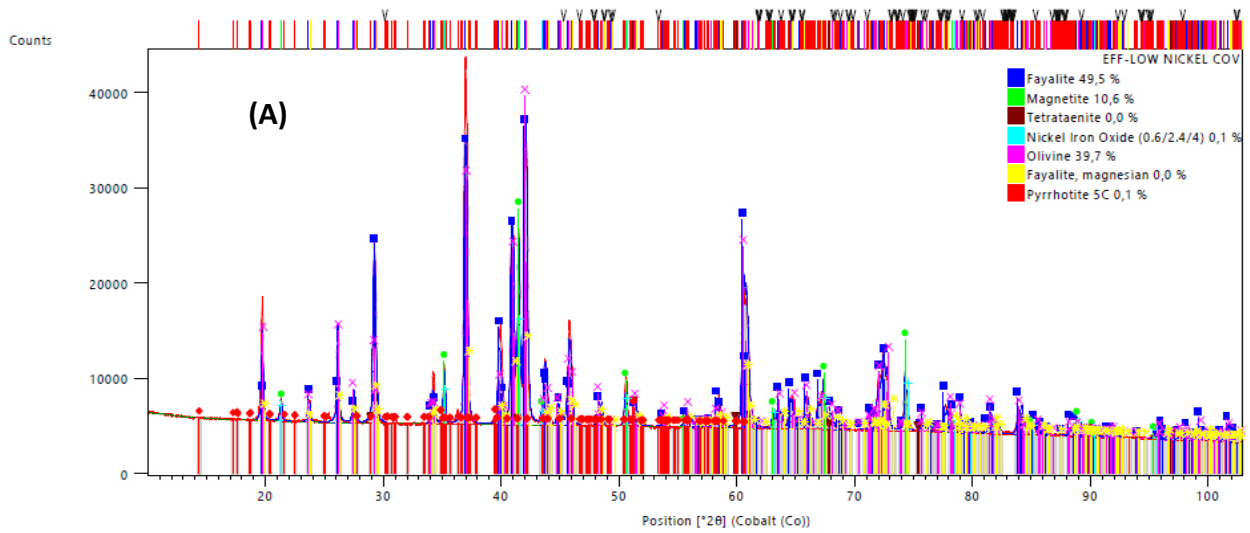
Figure 16A. XRD results of low nickel slag converter

Figure 17, high-nickel slag contains a phase that is highly reactive toward iron (Fe) in the ladle, namely nickel oxide (NiO), which is not detected in low-nickel slag (Wang, 2017; Dalvi et al., 2004). Consequently, low-nickel slag poses a lower corrosion risk to iron–carbon ladles. Figure 16A presents the XRD pattern of the low slag converter.

Low nickel slag converters are mostly composed of fayalite (Fe<sub>2</sub>SiO<sub>4</sub>) and olivine ((Fe,Mg)<sub>2</sub>SiO<sub>4</sub>). Figure 15B is the XRD results from high nickel slag converters.

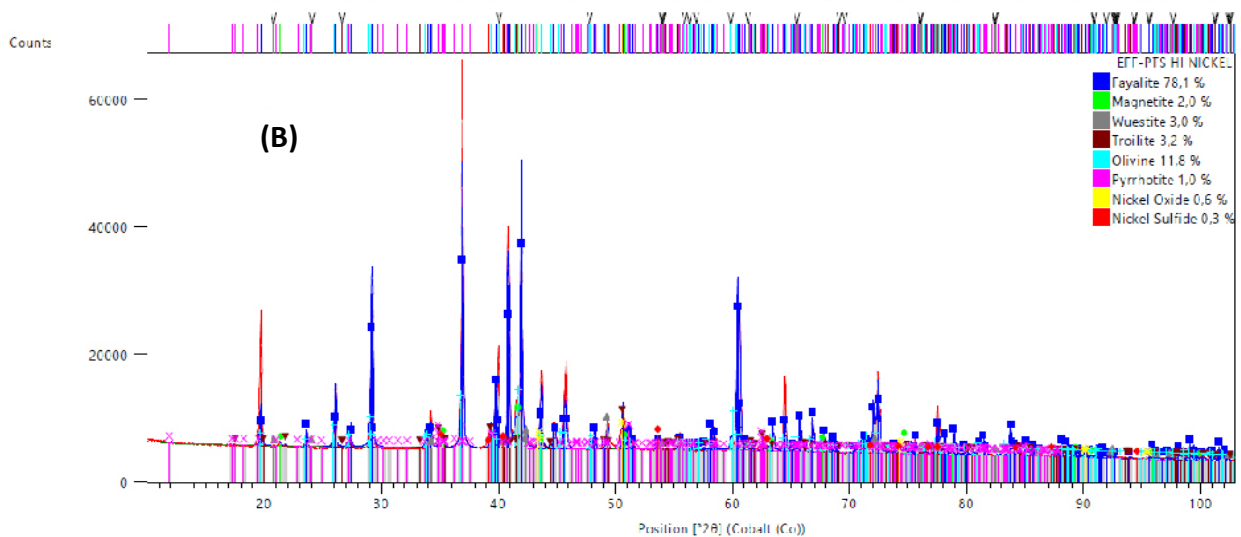
Figure 16B. Results of XRD high nickel slag converter

Figure 16 demonstrates that high-nickel converter slag differs in composition from low-nickel converter slag. Compounds such as nickel oxide and nickel sulfide are present only in the high-nickel converter slag. As discussed earlier, nickel oxide (NiO) is highly reactive with iron (Fe). Consequently, when high-nickel converter slag penetrates the original ladle material, which is predominantly composed of iron, the iron in the ladle undergoes oxidation according to the following reaction Equation 1.

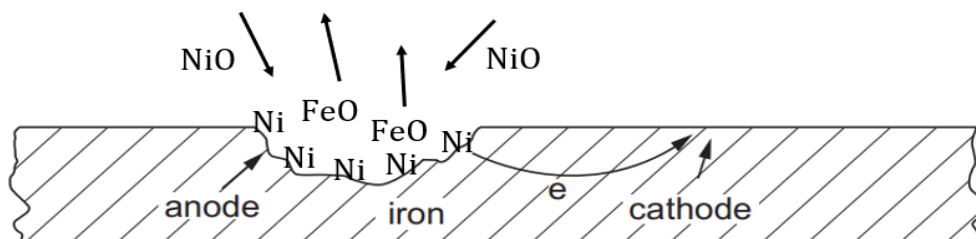
Figure 17. Illustration of failure in ladle

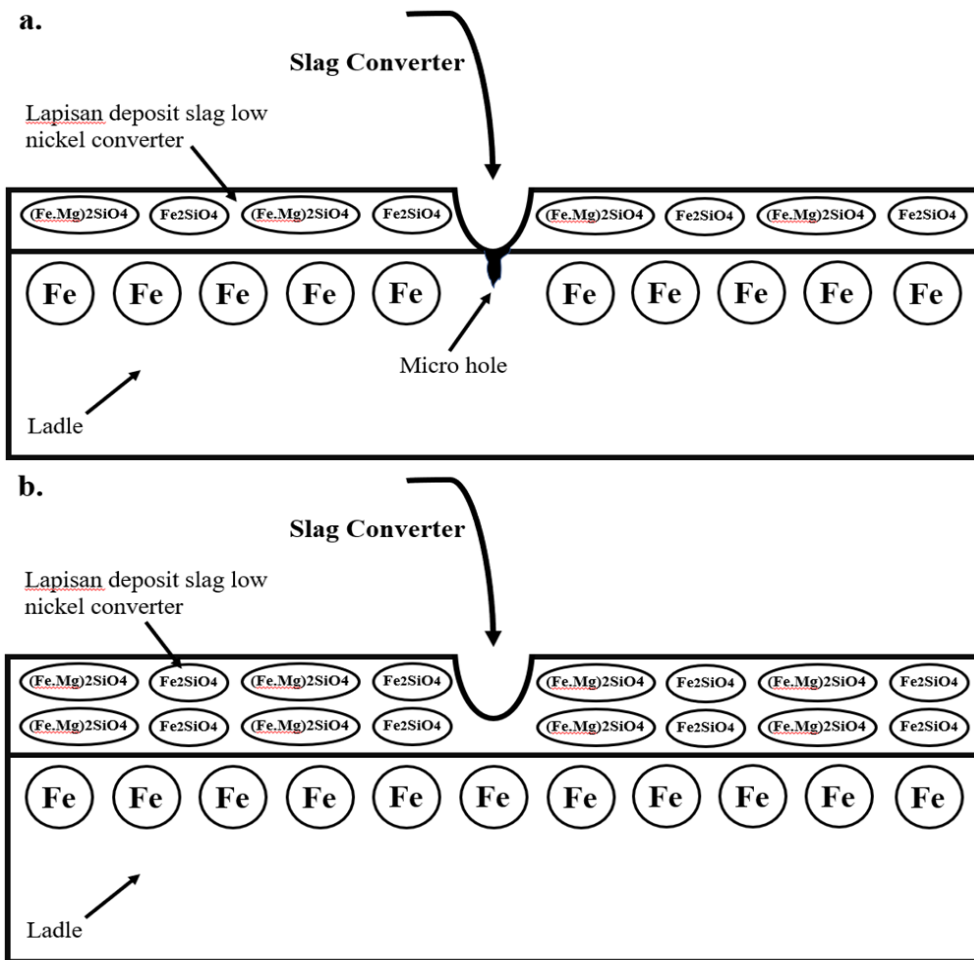
extensively; smaller pits coalesce to form larger perforations, as illustrated in Figure 11a. In contrast, reaction (1) does not occur when a sufficiently thick low-nickel converter slag deposit layer is present on the ladle wall (Figure 18).

Figure 18. Illustration of the Effect of Thin low nickel slag converter deposits (a) and thick low nickel slag converter deposits (b)

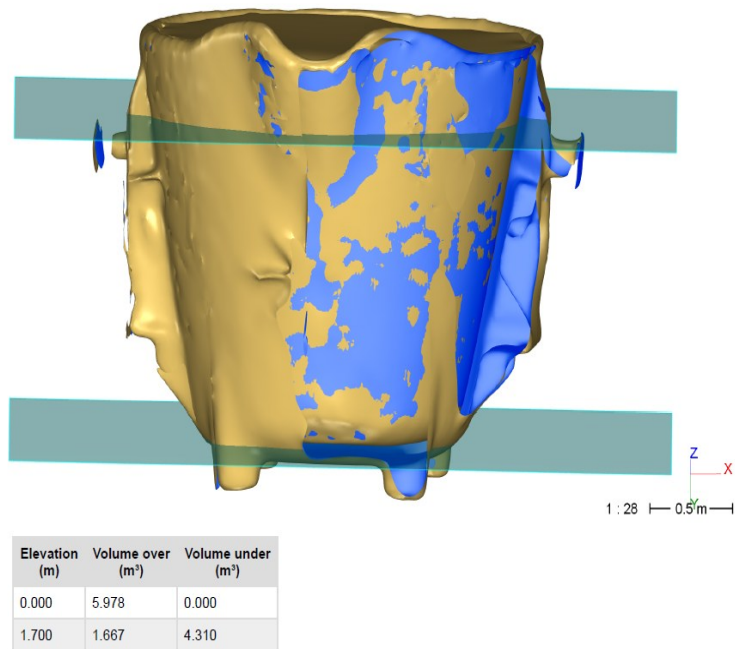
The measured volume corresponds to the space extending from the base of the ladle to the trunnion, as illustrated in Figure 19. The results indicate that the empty (blank) ladle has a volume of 4.31 m<sup>3</sup>. Subsequent volume measurements were conducted during the first through fifth low-nickel converter slag holding cycles, yielding the results presented (Figure 19).

Figure 19. Measurement results for the blank ladle volume
