## **Failure Analysis of Ladle Leakage and Wall Deposit Formation with Low-Nickel Slag Converterin Rotary Kiln–Electric Furnace Nickel Smelting (RKEF)**

Fajar Aditya<sup>1</sup>, Sutarsis<sup>1</sup>, and Meyliana Wulandari<sup>2</sup>

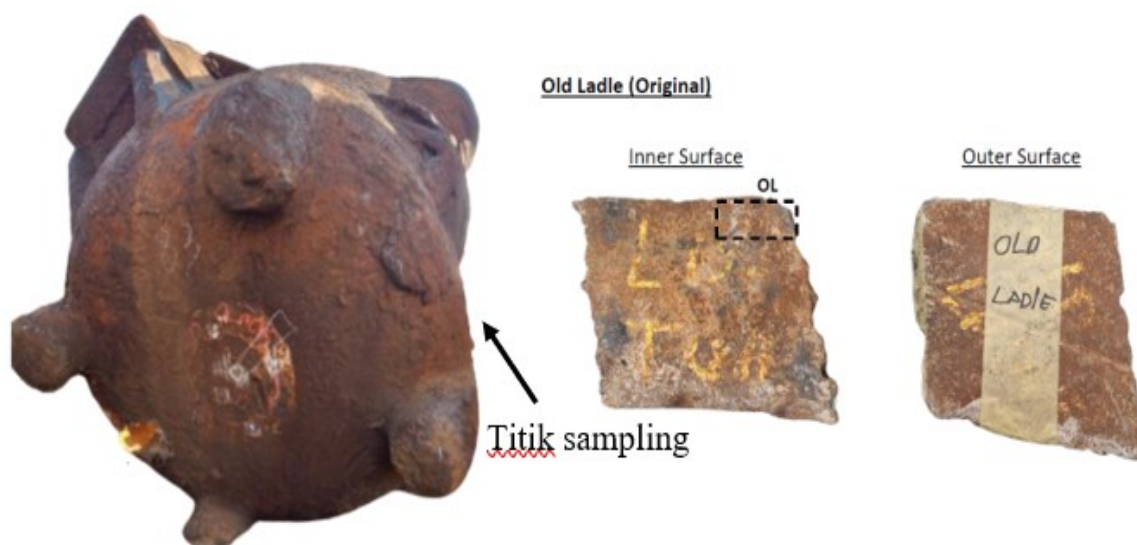
Figure 3. Old ladle sampling point

Failure analysis of the ladles was conducted through microstructural examination using an optical microscope and surface morphology analysis using SEM–EDX. In addition, phase identification and chemical characterization of the slag were performed using XRD and XRF on low-nickel and high-nickel converter slag samples. The analysis of low-nickel converter slag deposit formation inside the ladle was carried out through a series of slag-holding trials up to the fifth cycle. During each holding cycle, the ladle wall temperature was measured using a thermal imaging camera, while deposit volume was determined using a LiDAR camera and calculated based on differences volume before and after measurement. To support this study, samples were collected from both old and new ladles from the nickel smelting industry. Figure 3 shows a sample from the old casting mold taken from the outer wall of the mold.

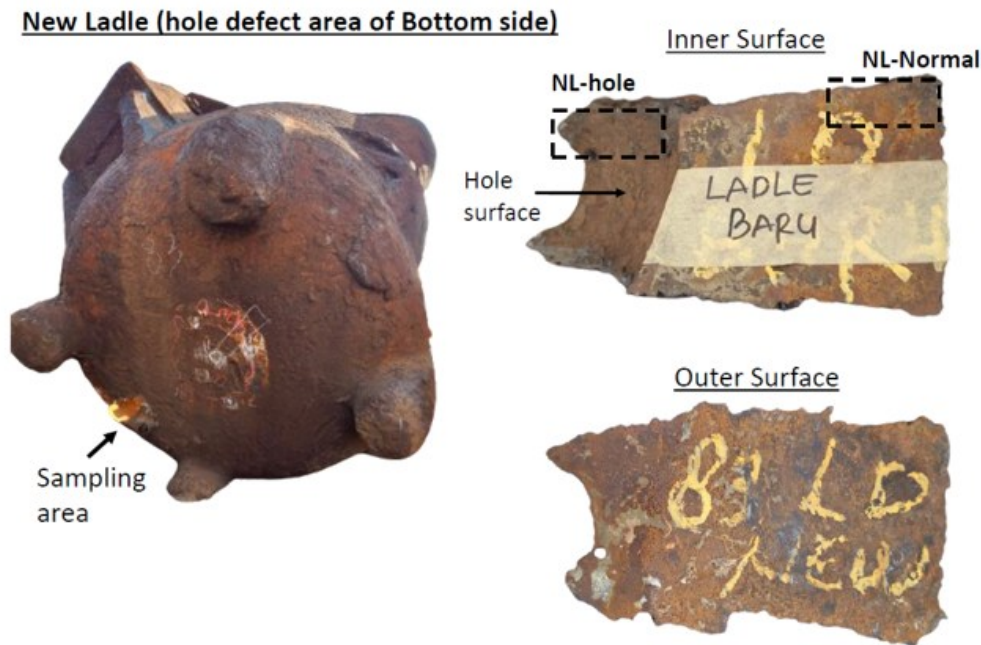
Figure 4. New ladle and leaking ladle sampling points

Figure 4 shows samples from a new casting mold and a damaged casting mold, taken from the same mold but from different locations. The sample from the new casting mold was taken from an undamaged section, while the sample from the damaged casting mold was taken directly from the area where the leak occurred.

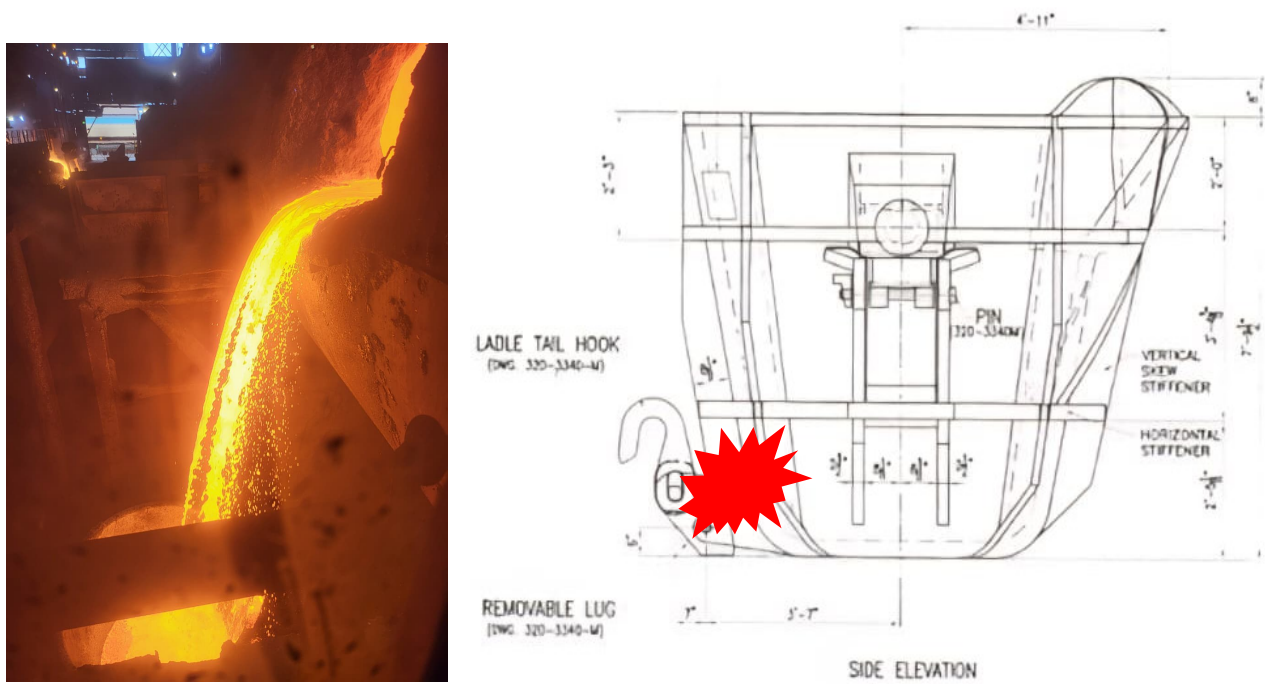
Figure 8. Slag pouring scheme from converter to ladle

Figure 7 indicates that the ladle thickness in the leaking area has been reduced to 39 mm from its original thickness of 90 mm. This region is particularly susceptible to high mechanical loads from slag and matte during the pouring process from the converter, as illustrated in Figure 8. In addition to the mechanical load concentrated in the ladle hook area during the initial slag pouring from the converter, it was observed that the low-nickel converter slag deposit within the ladle was relatively thin.

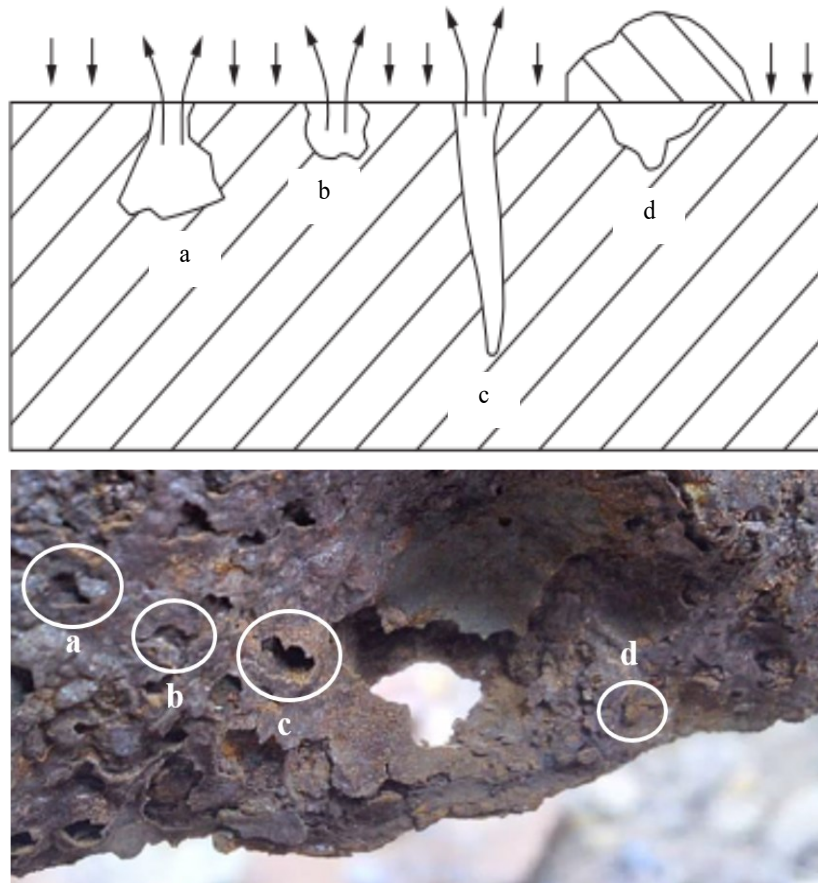
Figure 12. Mechanism of pitting corrosion (general aspects of corrosion, corrosion control, and prevention, part 1)

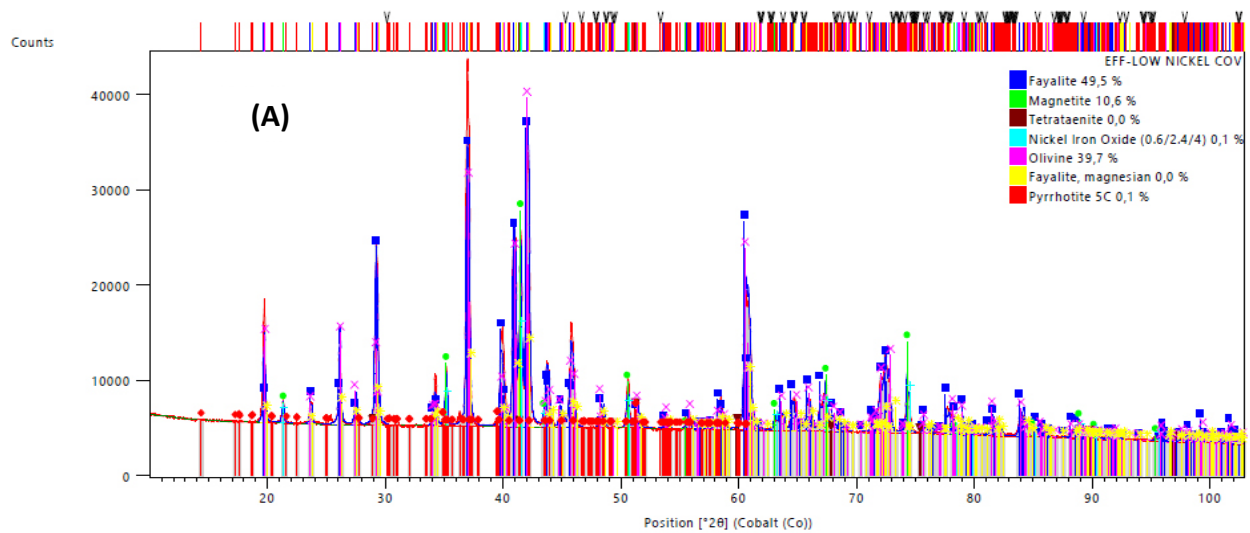
Figure 16A. XRD results of low nickel slag converter

Figure 17, high-nickel slag contains a phase that is highly reactive toward iron (Fe) in the ladle, namely nickel oxide (NiO), which is not detected in low-nickel slag (Wang, 2017; Dalvi et al., 2004). Consequently, low-nickel slag poses a lower corrosion risk to iron–carbon ladles. Figure 16A presents the XRD pattern of the low slag converter.

Low nickel slag converters are mostly composed of fayalite ( $\text{Fe}_2\text{SiO}_4$ ) and olivine ( $(\text{Fe.Mg})_2\text{SiO}_4$ ). Figure 15B is the XRD results from high nickel slag converters.

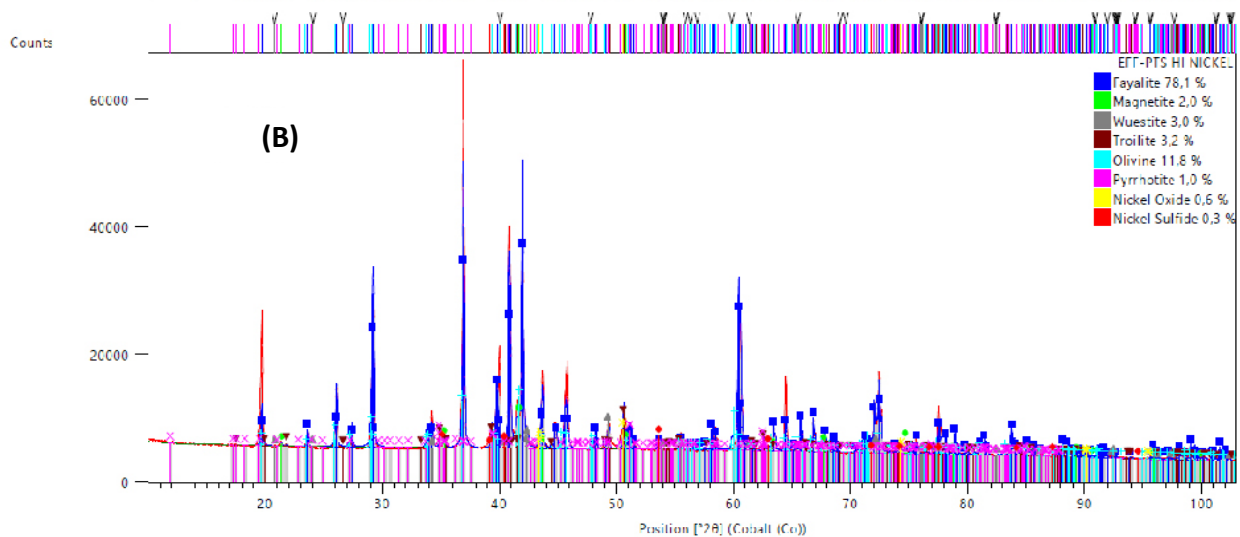
Figure 16B. Results of XRD high nickel slag converter

Figure 16 demonstrates that high-nickel converter slag differs in composition from low-nickel converter slag. Compounds such as nickel oxide and nickel sulfide are present only in the high-nickel converter slag. As discussed earlier, nickel oxide (NiO) is highly reactive with iron (Fe). Consequently, when high-nickel converter slag penetrates the original ladle material, which is predominantly composed of iron, the iron in the ladle undergoes oxidation according to the following reaction Equation 1.

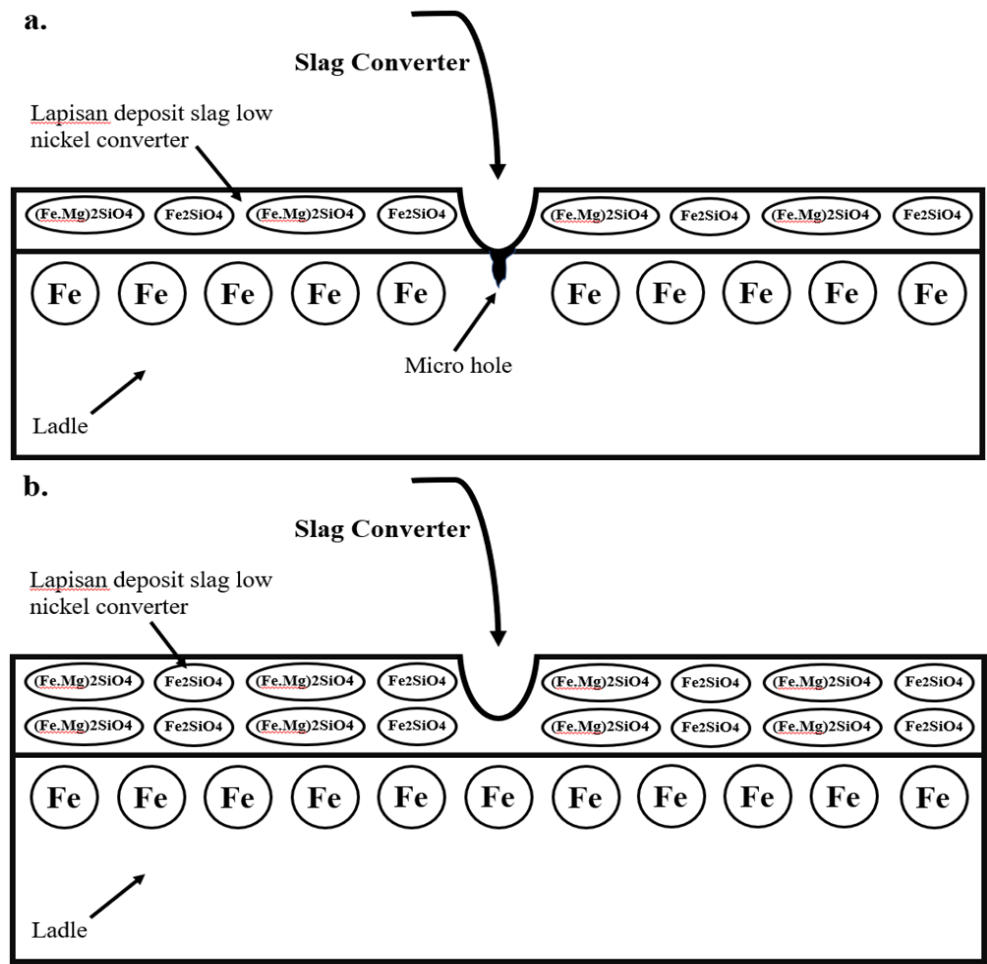
Figure 18. Illustration of the Effect of Thin low nickel slag converter deposits (a) and thick low nickel slag converter deposits (b)

extensively; smaller pits coalesce to form larger perforations, as illustrated in Figure 11a. In contrast, reaction (1) does not occur when a sufficiently thick low-nickel converter slag deposit layer is present on the ladle wall (Figure 18).

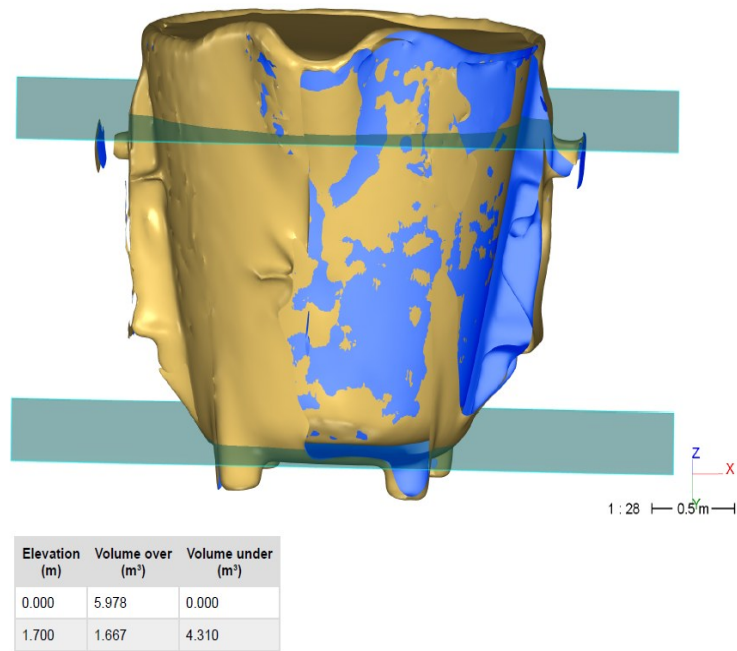
Figure 19. Measurement results for the blank ladle volume

The measured volume corresponds to the space extending from the base of the ladle to the trunnion, as illustrated in Figure 19. The results indicate that the empty (blank) ladle has a volume of 4.31 m<sup>3</sup>. Subsequent volume measurements were conducted during the first through fifth low-nickel converter slag holding cycles, yielding the results presented (Figure 19).
